Extract taken from: Entry certification > Reference materials > Examples of major structural damage and corrosion > Damage to the vehicle's outer body panels: seam or joint integrity

71-9 Damage to the vehicle's outer body panels: seam or joint integrity

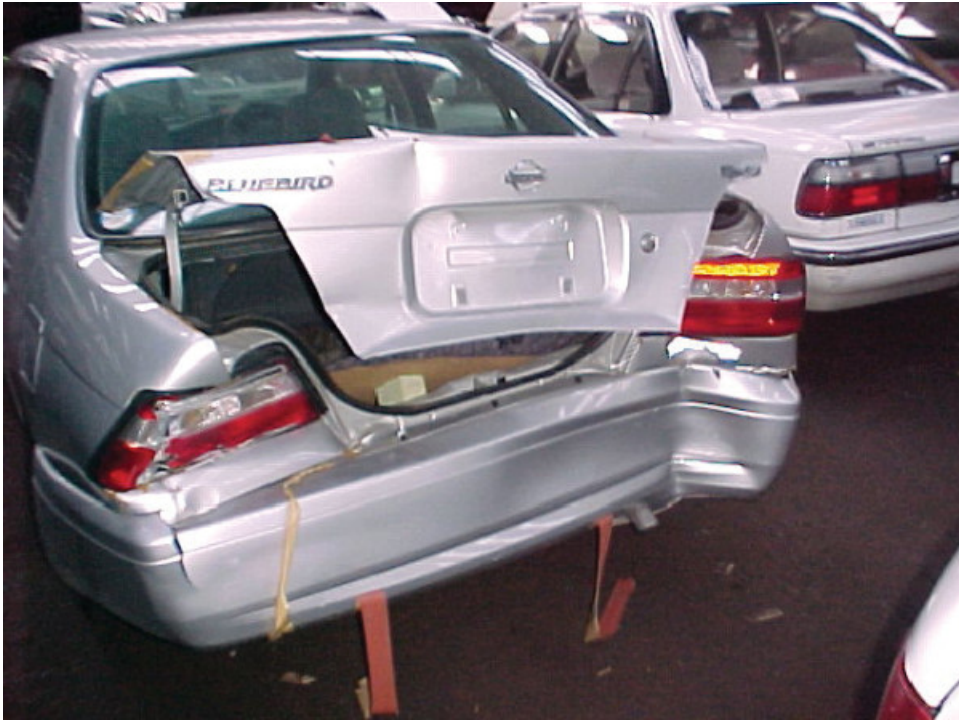
Damage to the vehicle's outer body panels which affect the integrity of any of the seams or joints installed by the vehicle manufacturer (and may have also caused secondary damage - further inspection may be required)
