**Extract taken from:** Border inspection of imported used vehicles > Reference materials > Examples of major structural damage and corrosion > Damage to the vehicle's outer body panels: seam or joint integrity

## **5-9 Damage to the vehicle's outer body panels: seam or joint integrity**

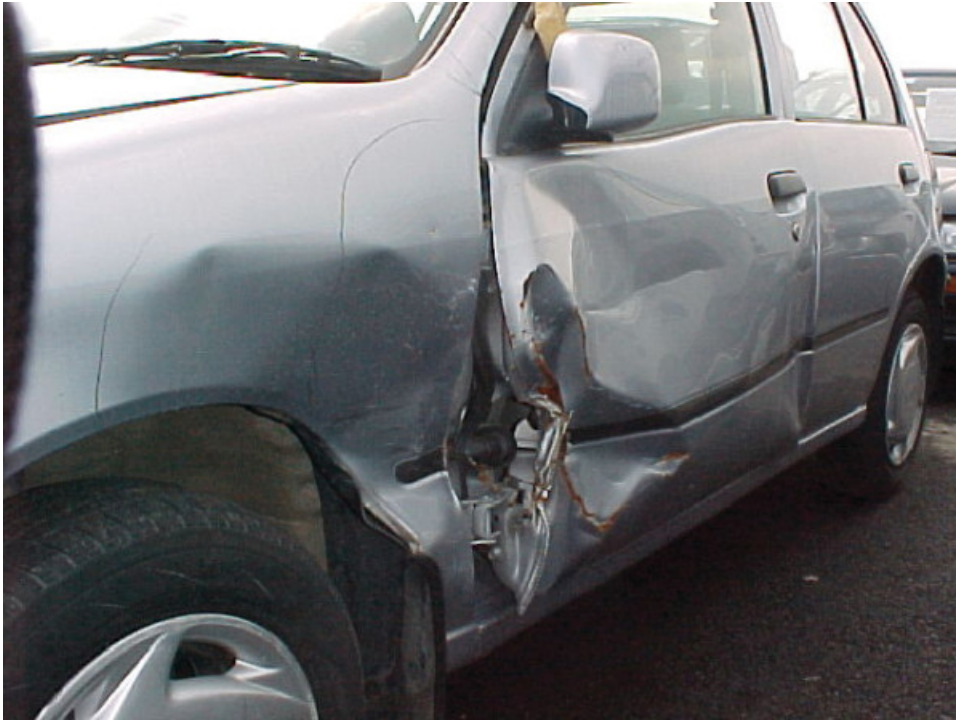
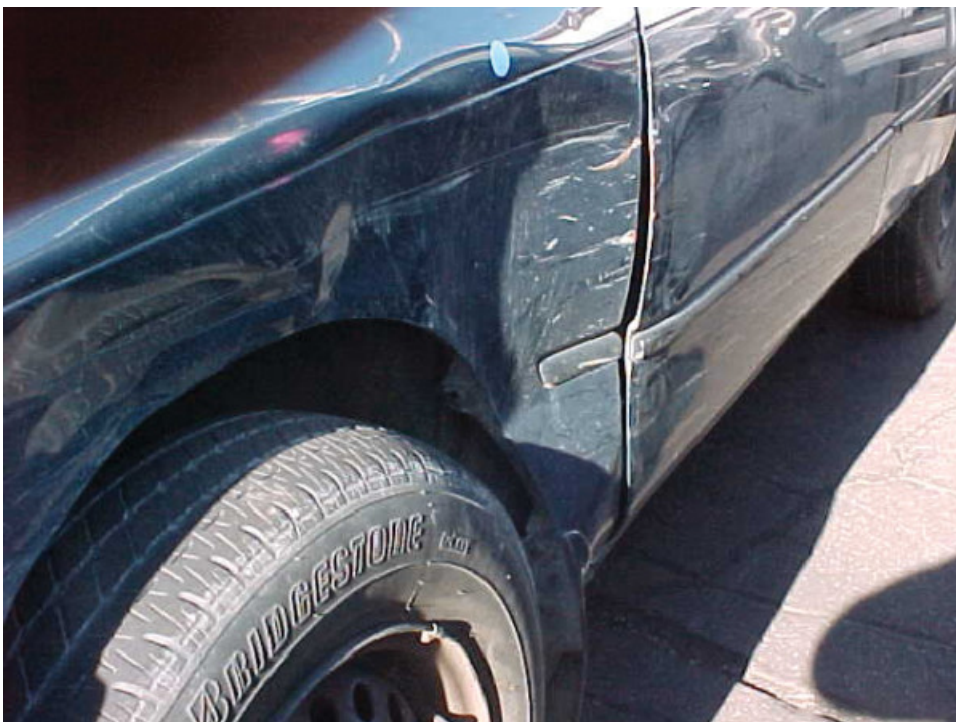
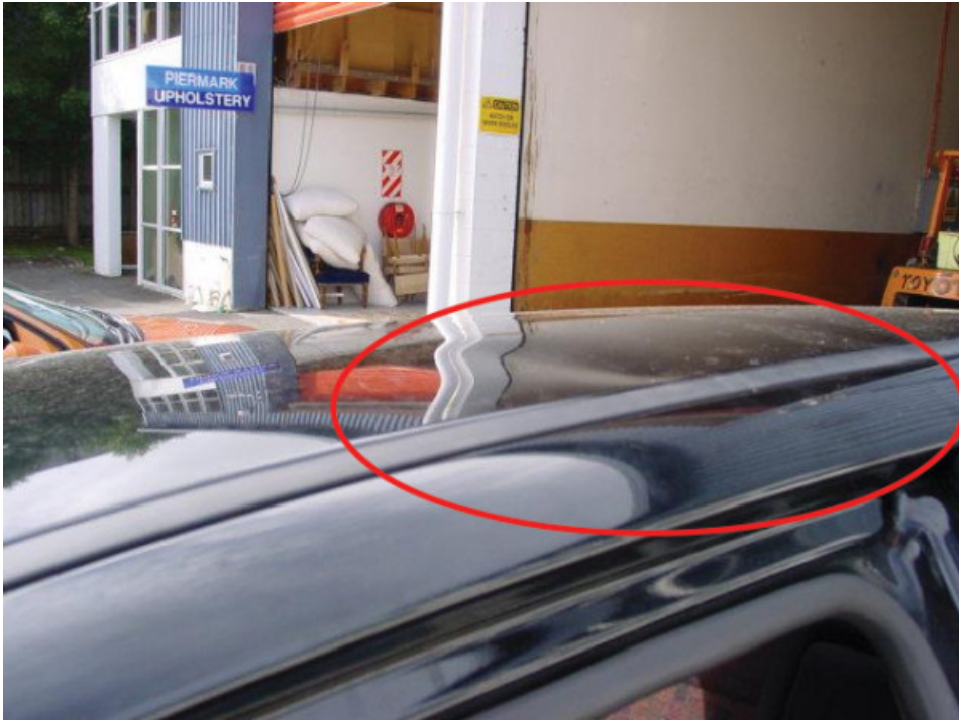
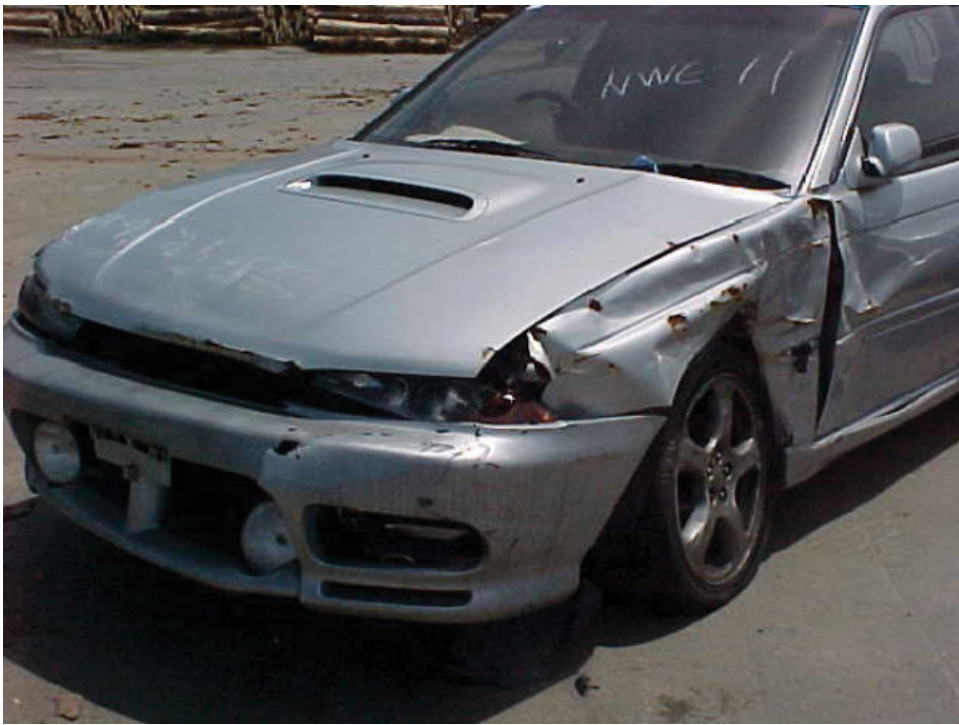
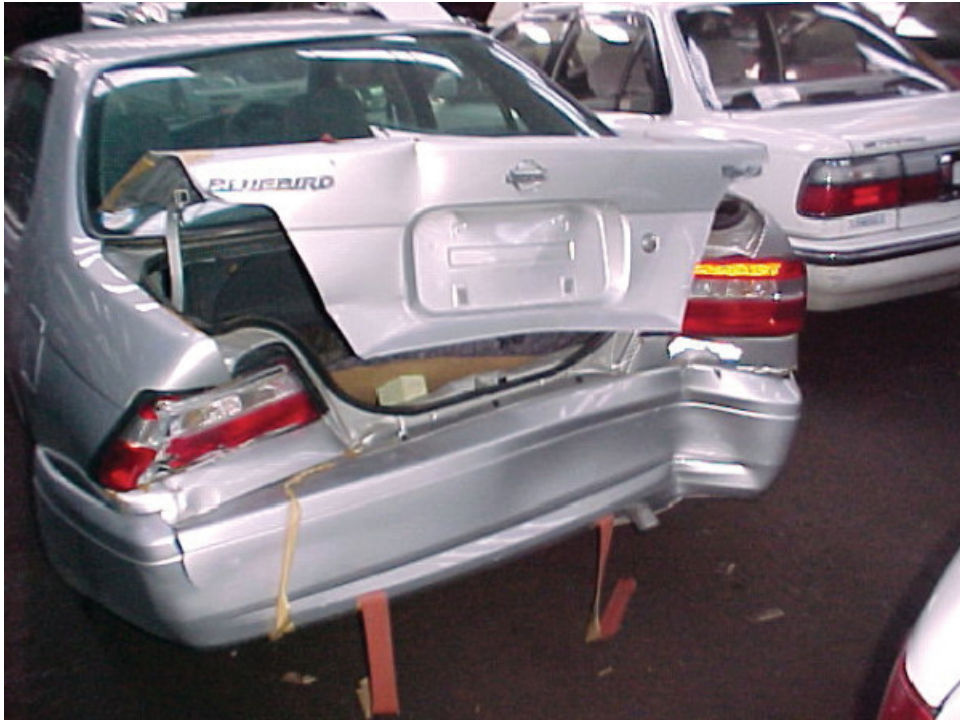
**Damage to the vehicle's outer body panels which affect the integrity of any of the seams or joints installed by the vehicle manufacturer (and may have also caused secondary damage - further inspection may be required)**
