Extract taken from: Border inspection of imported used vehicles > Reference materials > Examples of major structural damage and corrosion > Damage to the vehicle's outer body panels: seam or joint integrity

## 5-9 Damage to the vehicle's outer body panels: seam or joint integrity

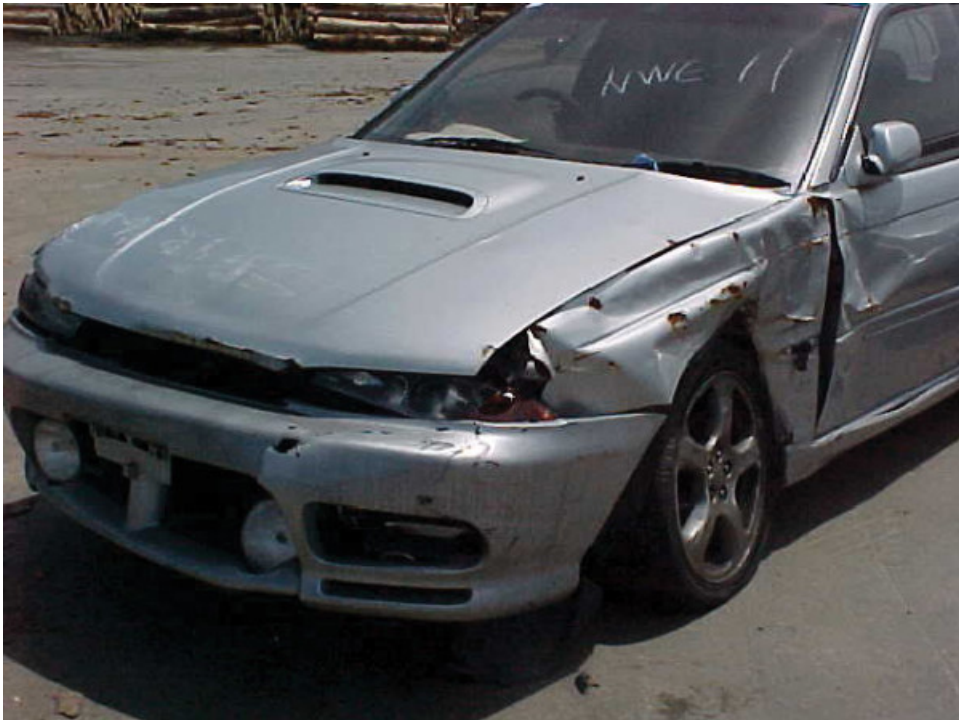
Damage to the vehicle's outer body panels which affect the integrity of any of the seams or joints installed by the vehicle manufacturer (and may have also caused secondary damage - further inspection may be required)
