Extract taken from: In-service certification (WoF and CoF) > Technical bulletins (CoF)

## Technical bulletins (CoF)

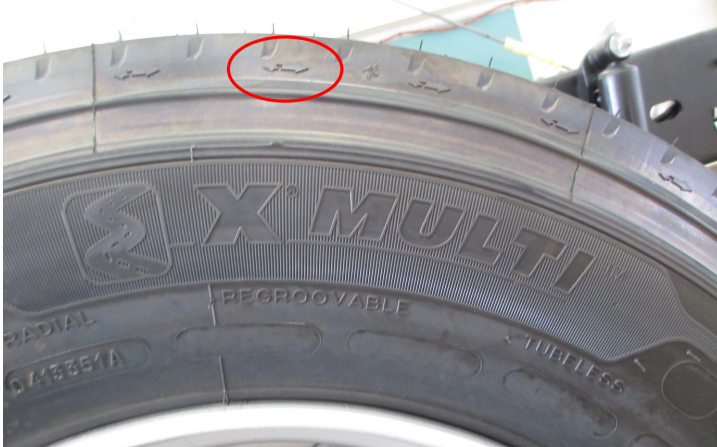
Michelin X Multiway tyres are like a cross between directional and normal highway tyres however the direction of rotation can be in either direction - meaning the tyre fits into the normal highway tread type classification.

The arrow with the larger head indicates the manufacturer's preferred direction of rotation for the tyre, optimizing tread wear performance. The manufacturer recommends that, especially when new, tyres marked with a bi-directional arrow should be run in the direction of rotation indicated by the larger arrow head.

However, if a tyre marked with the bi-directional arrow shows an irregular wear profile, (for example, a sloped wear pattern) then it may be turned on the rim and run in the direction of the smaller arrow head with no detriment to any other performance criteria. In cases such as this, the manufacturer recommends that all tyres on the same axle should be turned on the rim such that all arrows face in the same direction.

- Despite the manufacturer's recommendation, there is no reason for rejection if the bi-directional arrows do not face in the same direction.
- There is no reason for rejection if tyres with bi-directional arrows are mixed on the same axle with other Normal Highway tread type tyres.
- Tyres with bi-directional arrows cannot be mixed with asymmetric or directional tyres.

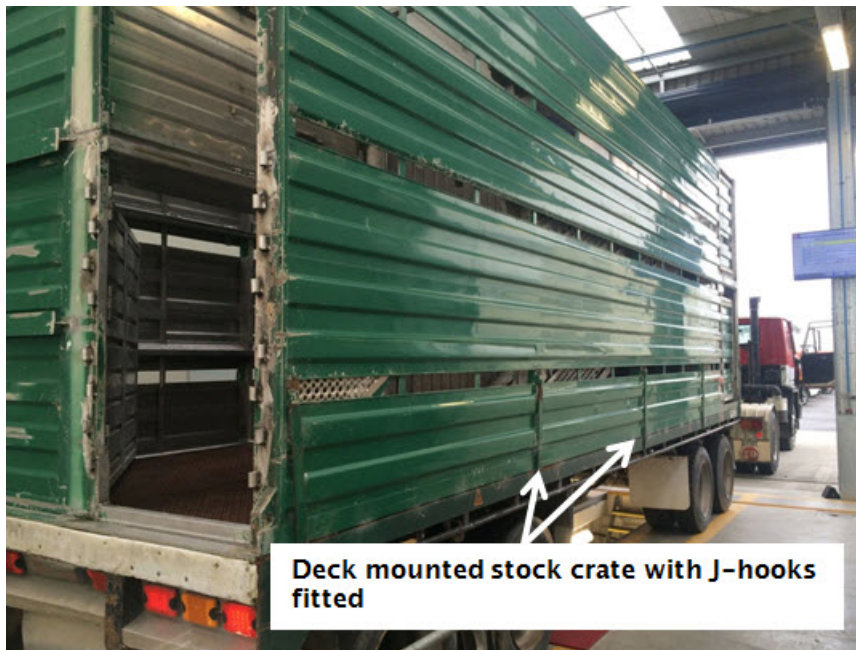
**Figure 7-1-1. J-hook stock crate**

The crate attachment is easy to see as the J-hooks sit on the outside (Figure 7-1-1).

The stock crate is not a vehicle therefore the actual crate J-hook mountings and J-hooks **cannot be certified with an LT400**. The design can be certified with a design certificate and a plate or label attached to the stock crate.

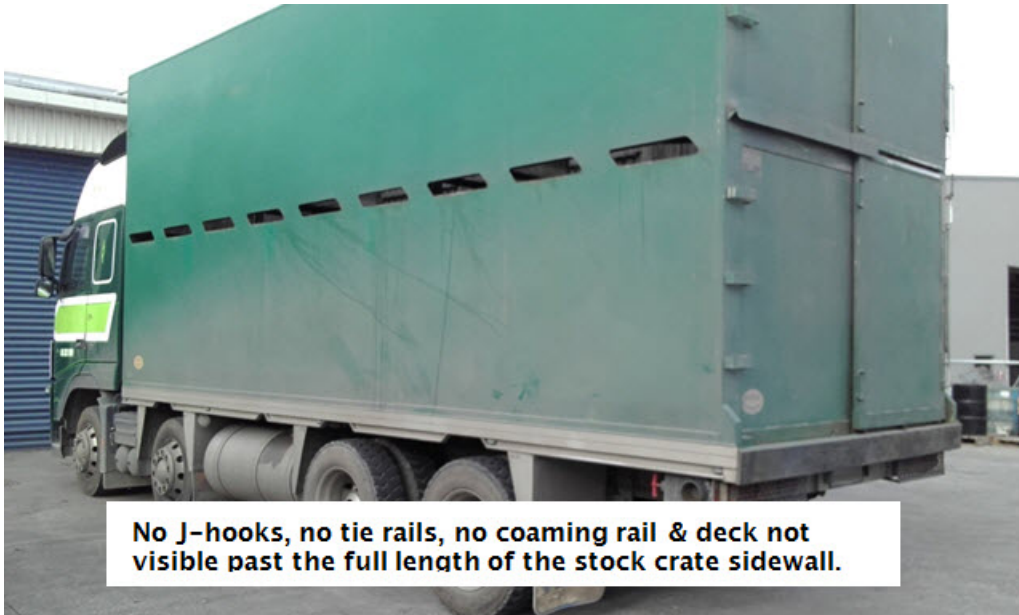
**Figure 7-1-2. Monocoque stock transfer vehicle**

This must be certified to NZS5413.

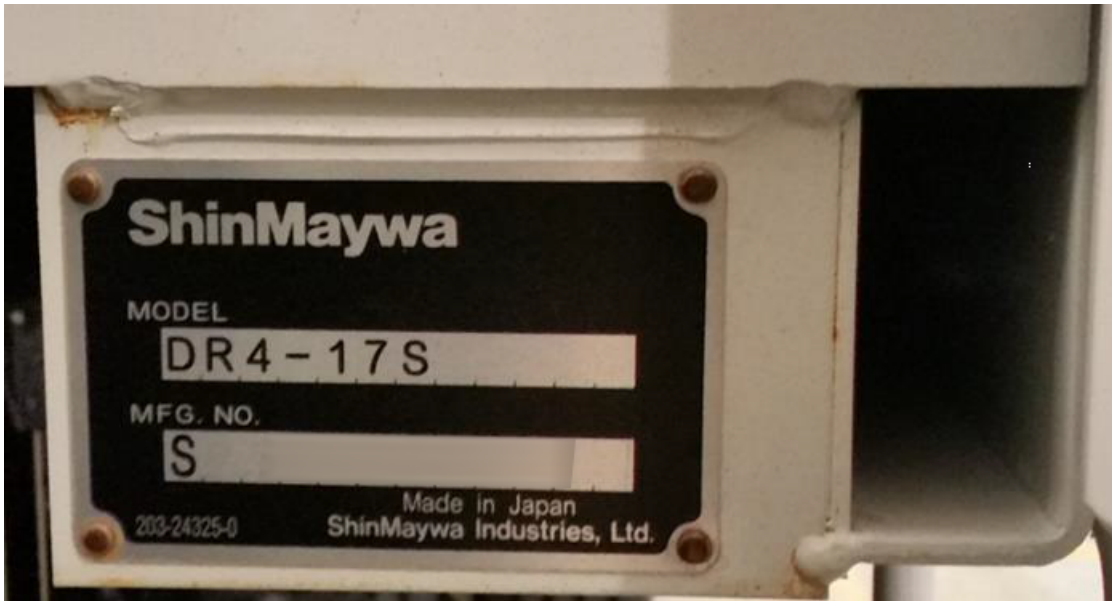
Trucks fitted with ShinMaywa tipper bodies will be fitted with a plate as shown in the sample below.

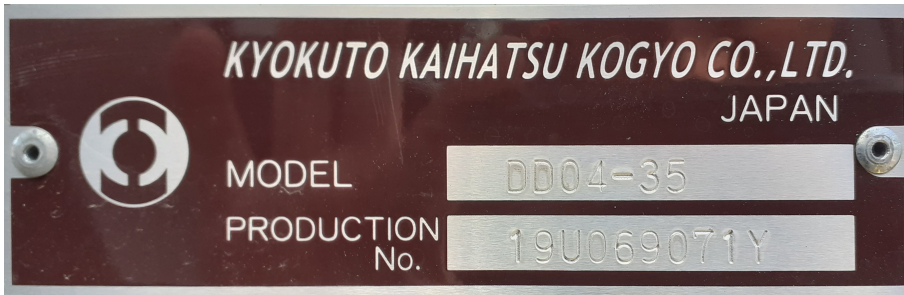
Trucks fitted with Fuso tipper bodies can be fitted with either the plate shown below or the ShinMaywa body builders plate (above).
