**Extract taken from:** In-service certification (WoF and CoF) > Light PSVs > Lighting > Direction indicator lamps

## **4-5 Direction indicator lamps**

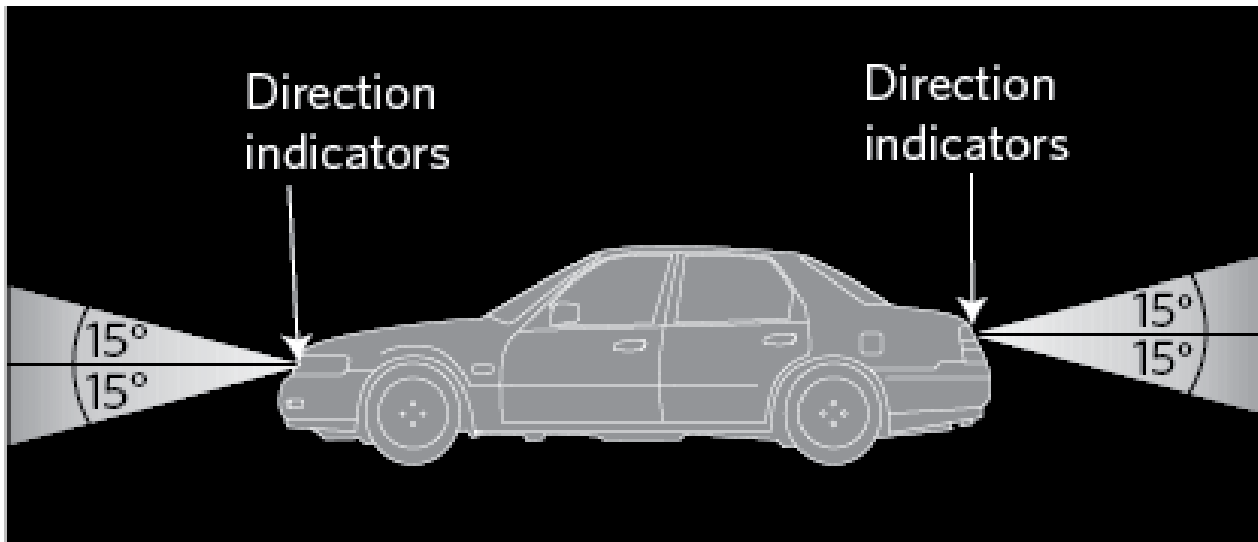
Figure 4-5-1. Direction indicator beam angles

18. A non-OE mandatory lamp mounted outside the original position emits a light that is not visible within (Figure 4-5-1):
  - a) 15° above and below the horizontal, or

- b) 45° inboard or 80° outboard.
19. An overlay has been applied that reduces or distorts the light emitted from the lamp (eg a tinted cover).
20. A modification to the vehicle has reduced the visibility angles of a mandatory lamp to less than (Figure 4-5-1):

(a) Vertical beam angles

- a) 15° above and below the horizontal, or
  - b) 45° inboard or 80° outboard.
21. On a vehicle of American origin fitted with combined stop and indicator lamps, the stop lamp function is not overridden by the indicator function.

18. A retrofitted mandatory lamp must emit a light that is visible within angles of

a) 15° above and below the horizontal, and

b) 45° inboard, and

c) 80° outboard.

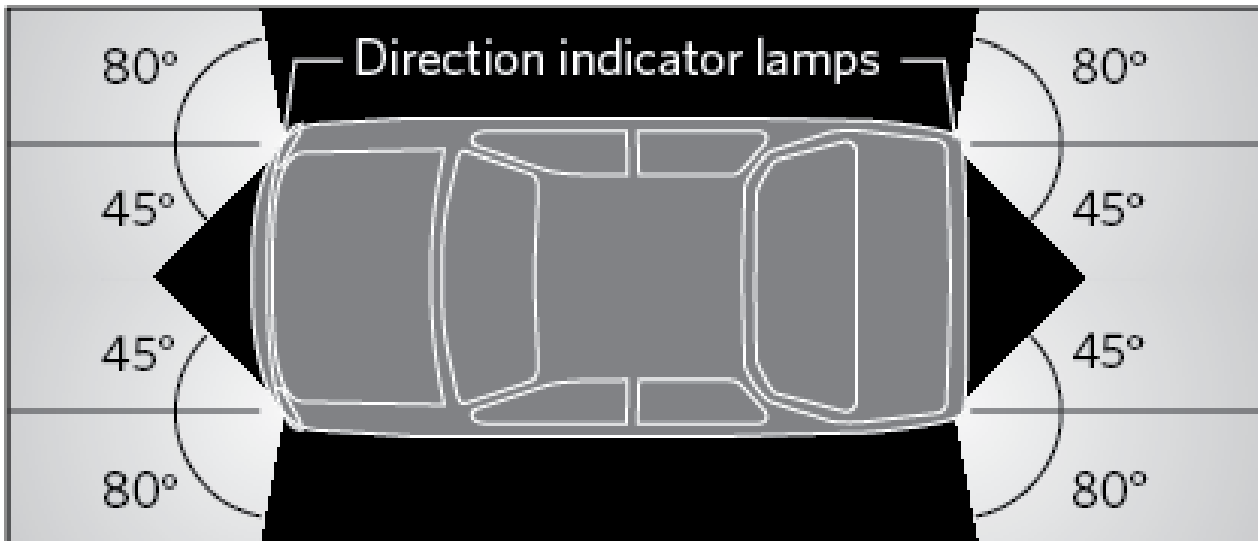
(b) Horizontal beam angles
