Extract taken from: In-service certification (WoF and CoF) > Heavy vehicles > Vehicle structure

3 Vehicle structure

3-1 Structure

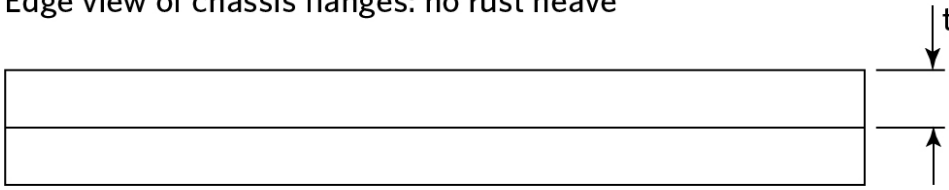
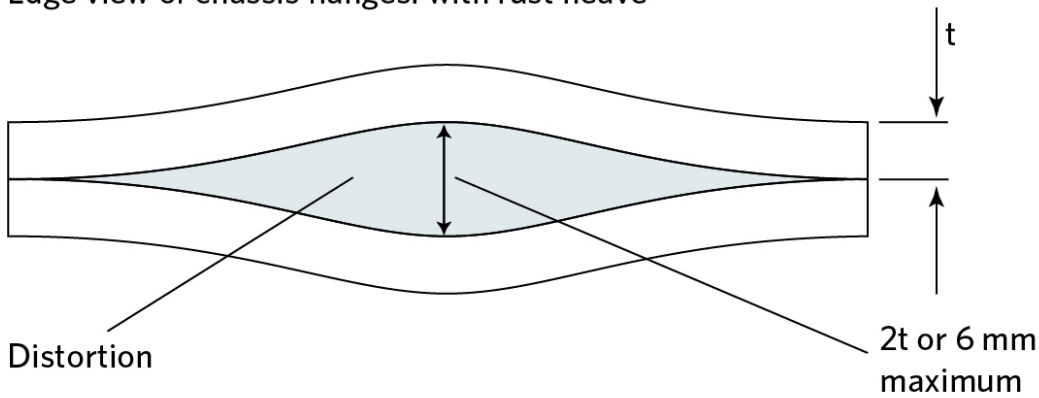
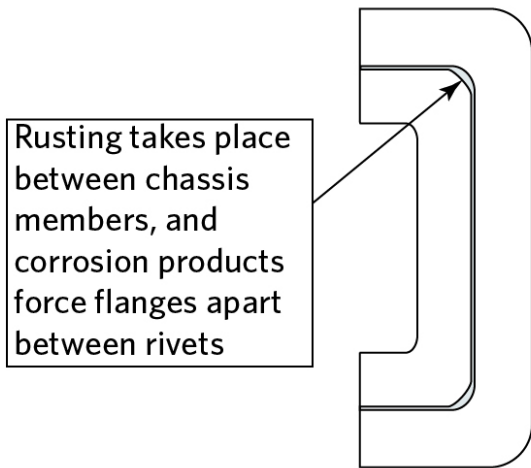
Figure 3-1-3. Rust heave limits

Edge view of chassis flanges: no rust heave

Edge view of chassis flanges: with rust heave

Apply similar criteria (twice material thickness or 6 mm maximum) for corrosion in other parts of structural members

Note: where the flanges are of different thickness, t shall be taken as the minimum of these.

- d) significant rust heave that exceeds the limits in (Figure 3-1-3), or
 - e) poor repairs that have not returned the structure to within safe tolerance of when it was manufactured, eg:

Rust heave beyond the limits described above is acceptable only if an HVS certifier with the HVEC category has confirmed in writing that at the time of inspection the identified chassis rust heave on the vehicle remains within safe tolerance of the vehicle's state of manufacture. Confirmation from the HVS certifier should be kept with the checksheet. The identity of the HVS certifier must be recorded in the Landata GNOTE page. This assessment is only valid for that specific CoF inspection.

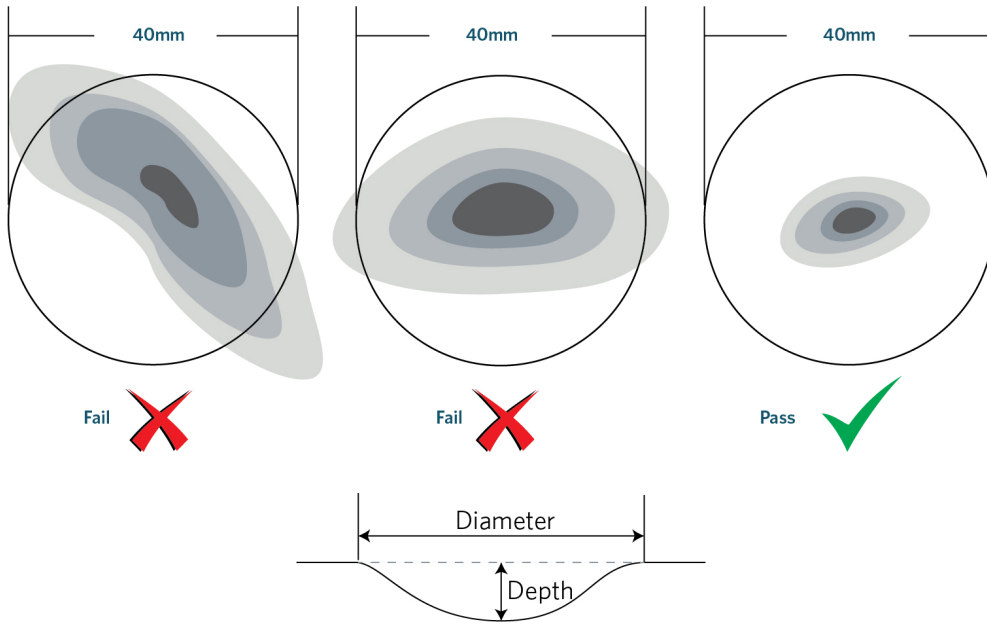
Figure 3-1-4. Deformation limits

Dents smaller than 5mm deep and 40mm in diameter (to the outer edges of the crease), such as those caused by hail, in the pillars, cant rail or any other similar roof structure, should not be considered to affect the vehicles structural integrity. Any damage larger than above should be referred to a repairer for additional information (see Figure 3-1-4).

- a) deformation from original shape that has affected the vehicle's structural integrity (Note 6) (Figure 3-1-4), or
 - b) cracking, or
 - c) significant corrosion or delamination, or

- a) deformation from original shape that has affected the vehicle's structural integrity (Note 6) (Figure 3-1-4), or
- b) significant cracking of the body structure or mounting points, or
- c) significant corrosion of steel elements, delamination, or wood rotting or
- d) significant rust heave in steel elements that exceeds the limits in (Figure 3-1-3), or
- e) poor repairs that have not returned the structure to within safe tolerance of when it was manufactured, for example:
 - i. filler has been used to conceal any damage or deformation of a component
 - ii. a high-strength steel component has been heated
 - iii. a component has been strengthened.
