Extract taken from: Border inspection of imported used vehicles > Technical bulletins > Vehicles fitted with ITS Connect

3 Vehicles fitted with ITS Connect

The purpose of this technical bulletin is to define a process for identifying vehicles fitted with ITS Connect systems and how these vehicles need to be processed if an ITS Connect system is fitted.

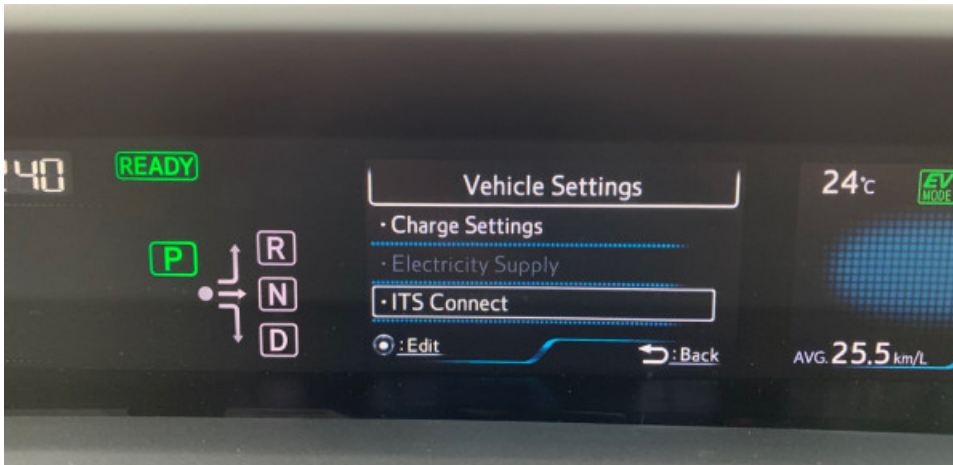
Figure 3. ITS Connect fitted as shown under vehicle settings

This vehicle would need to be damaged flagged and have the system removed.

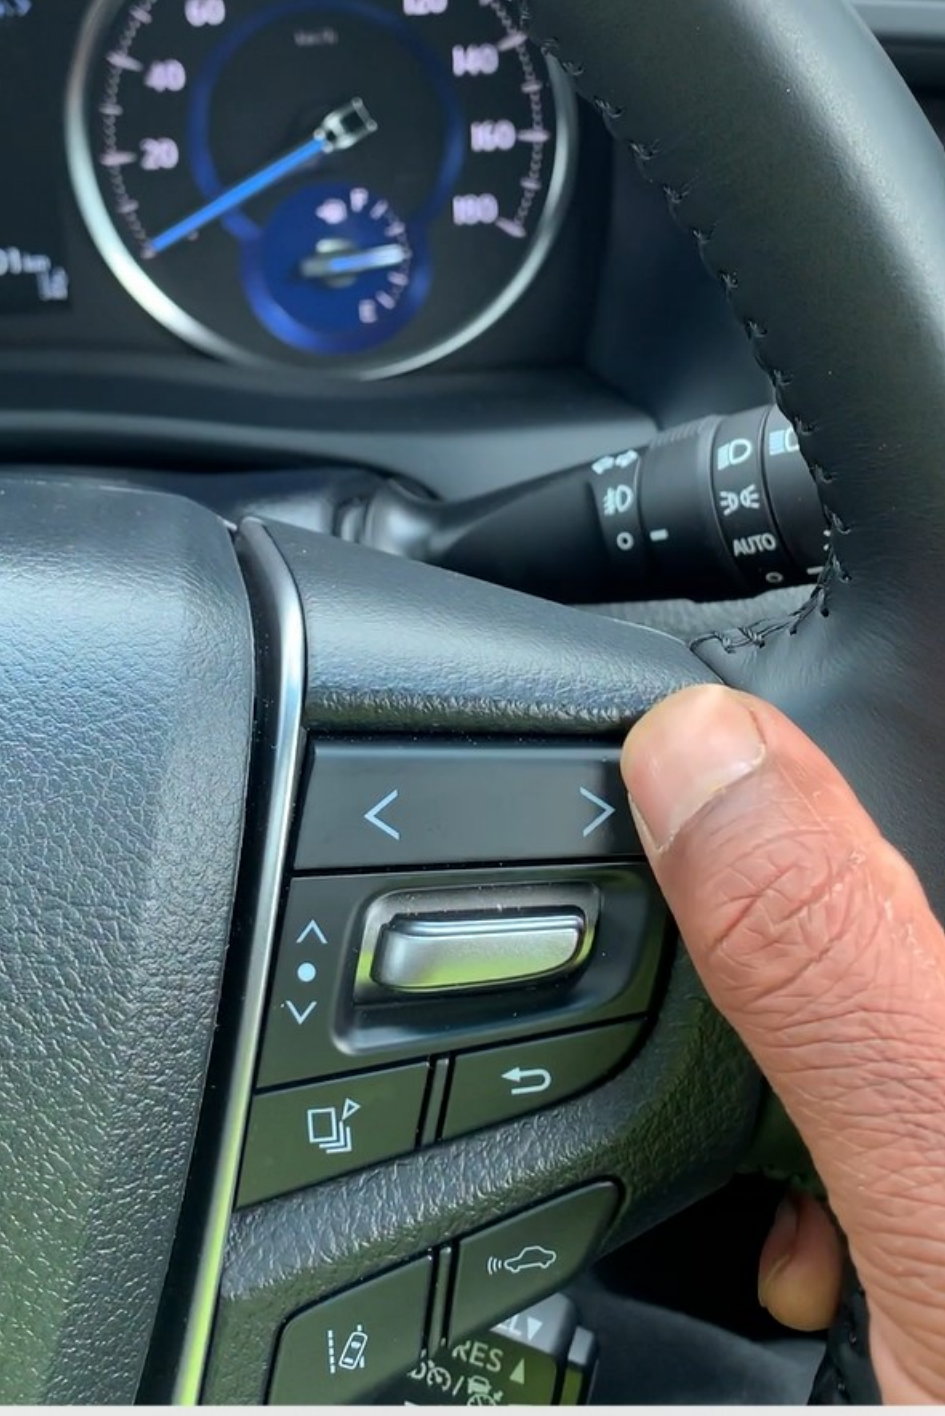
Figure 4. Vellfire MFD control buttons

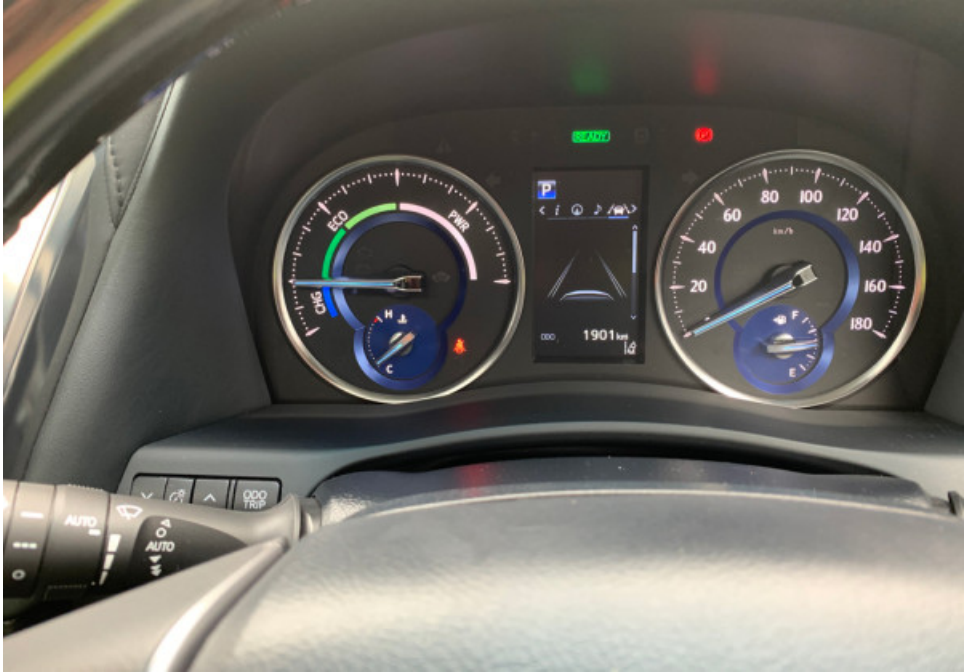
Figure 6. Scroll Right to find settings

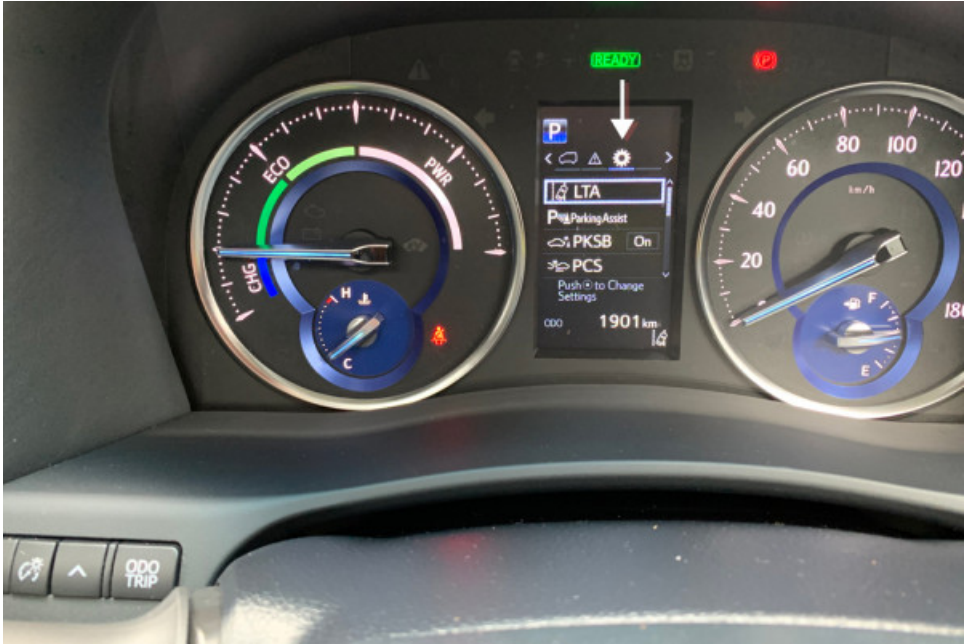
Figure 7. Select the gear icon for settings

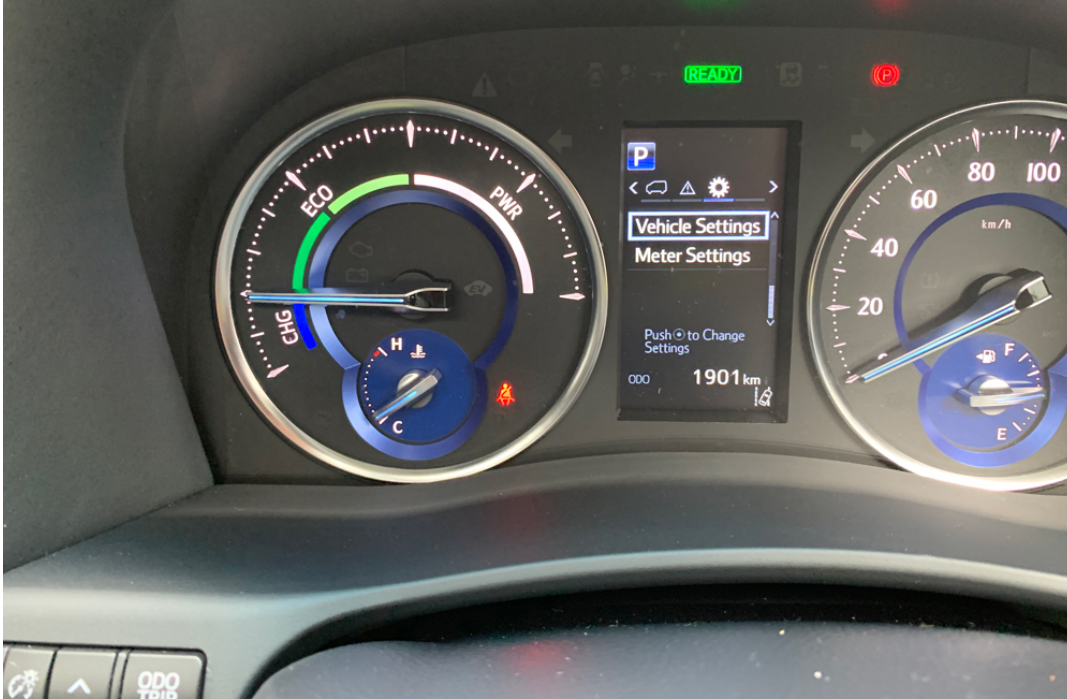
Figure 8. Scroll down and select 'Vehicle Settings'
