**Extract taken from:** Border inspection of imported used vehicles > Technical bulletins > Vehicles fitted with ITS Connect

### 3 Vehicles fitted with ITS Connect

The purpose of this technical bulletin is to define a process for identifying vehicles fitted with ITS Connect systems and how these vehicles need to be processed if an ITS Connect system is fitted.

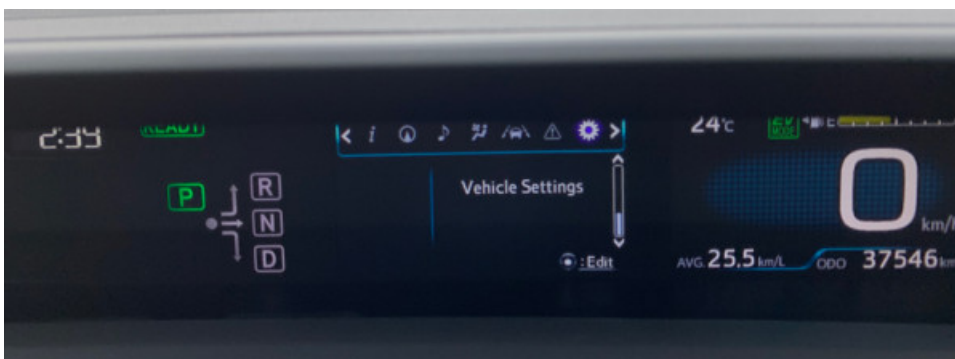
Figure 2. Setting screens

Use arrows on steering wheel control pad to move the selector

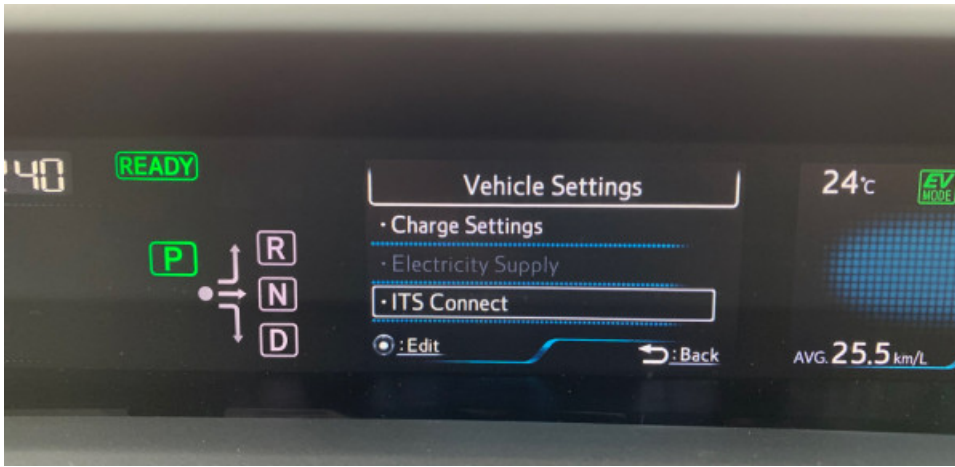
Figure 3. ITS Connect fitted as shown under vehicle settings

This vehicle would need to be damaged flagged and have the system removed.

A vehicle that has been found to be fitted with an ITS Connect system must have a damage flag placed on the vehicle with a note stating 'ITS Connect Fitted'. Any other damage or Takata airbag recall notes must also be added if applicable. The damage flag is to remain on the vehicle even if ITS-Connect is disabled in Japan. Note: The vehicle record should not be created on BIS until the vehicle has completed its final border inspection, once a damage flag has been placed the record cannot be edited.

The vehicle owner must take the vehicle to a Toyota or Lexus franchise in Japan to have the ITS Connect system removed. An invoice or receipt from the dealer that shows the vehicles chassis number and indicates that the system has been removed is acceptable evidence that ITS Connect is no longer fitted.

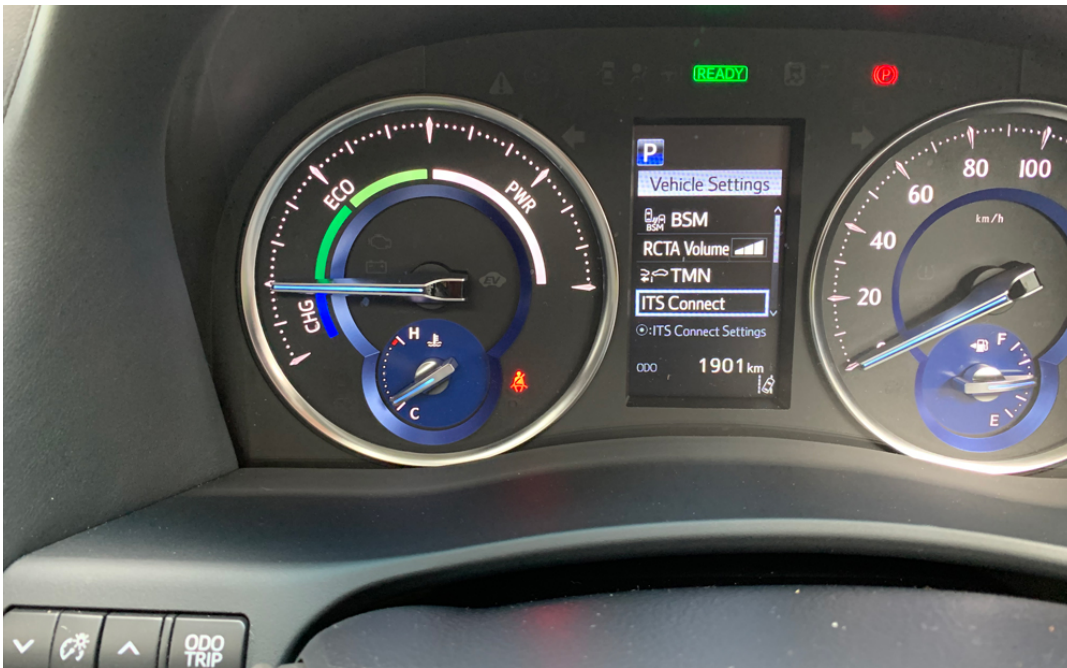
**Figure 9. Scroll down**

If ITS connect is fitted you will see the settings as below.
