Extract taken from: Border inspection of imported used vehicles > Technical bulletins > Acid wash process on used imports

4 Acid wash process on used imports

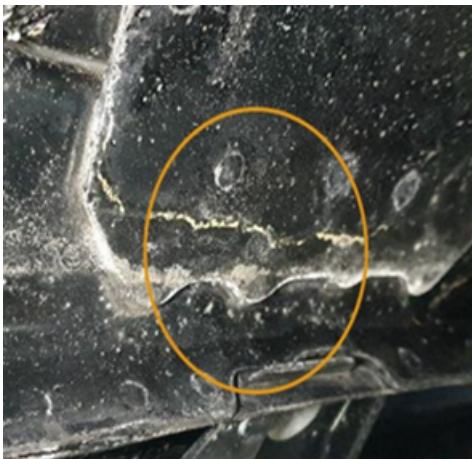
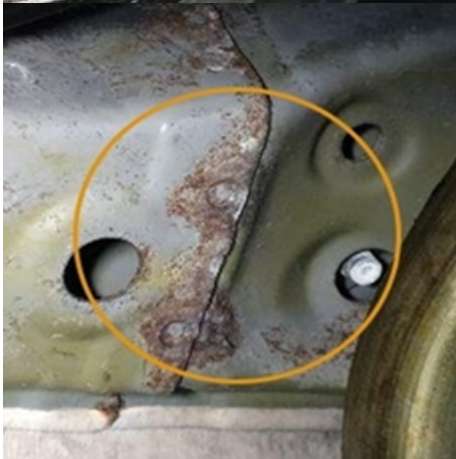
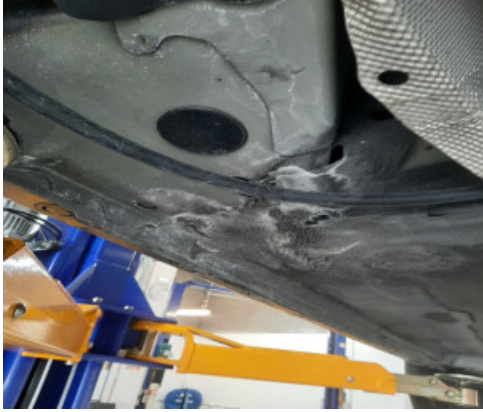
The process involves the use of a chemical mix containing an acid base liquid, phosphoric acid is commonly used, to remove corrosion and treat the metal area. The following photos show examples of visible signs of acid wash repair.

Visible signs of an acid wash repair include:

- The area has been cleaned and a clear topcoat, or no topcoat applied.
- A white residue is noticeable in joints, seams, or coming through underseal/topcoats.
- Corrosion is still visibly active in an area that has been treated.

An area of metal that has not been acid washed correctly will continue to degrade within a short time and can be detrimental to the vehicle structure.

When visible signs of acid wash repair as described above are observed by an inspector at an entry compliance inspection the vehicle must be failed and referred to a Repair Certifier for assessment.

The threshold for requiring repair certification instructs 'A vehicle must be referred to a specialist repair certifier if signs of repair, rust prevention, acid wash or under-sealing to any part of the vehicle structure are evident'. The repair certifier will assess the repair and decide if it requires remedial work and a *Light vehicle repair record of certification* (LT308) issued, or if the repair is acceptable a *No repair certification required declaration – light vehicle* (LT307) issued.
