Extract taken from: Border inspection of imported used vehicles > Technical bulletins > Acid wash process on used imports

4 Acid wash process on used imports

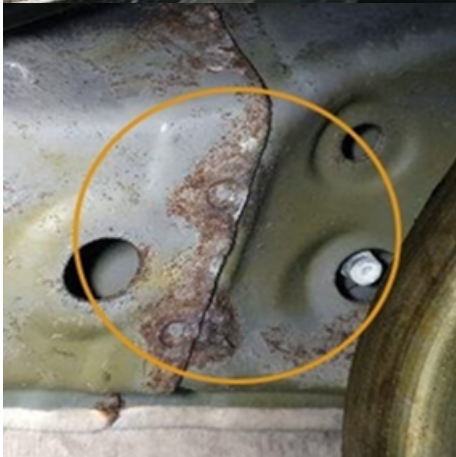
The process involves the use of a chemical mix containing an acid base liquid, phosphoric acid is commonly used, to remove corrosion and treat the metal area. The following photos show examples of visible signs of acid wash repair.

Visible signs of an acid wash repair include:

- The area has been cleaned and a clear topcoat, or no topcoat applied.
- A white residue is noticeable in joints, seams, or coming through underseal/topcoats.
- Corrosion is still visibly active in an area that has been treated.

An area of metal that has not been acid washed correctly will continue to degrade within a short time and can be detrimental to the vehicle structure.

When visible signs of acid wash repair as described above are observed by an inspector at an entry compliance inspection the vehicle must be failed and referred to a Repair Certifier for assessment.

The threshold for requiring repair certification instructs 'A vehicle must be referred to a specialist repair certifier if signs of repair, rust prevention, acid wash or under-sealing to any part of the vehicle structure are evident'. The repair certifier will assess the repair and decide if it requires remedial work and a *Light vehicle repair record of certification* (LT308) issued, or if the repair is acceptable a *No repair certification required declaration – light vehicle* (LT307) issued.
