Extract taken from: In-service certification (WoF and CoF) > General trailers > Towing connections

8 Towing connections

8-1 Light trailer drawbar and kingpin

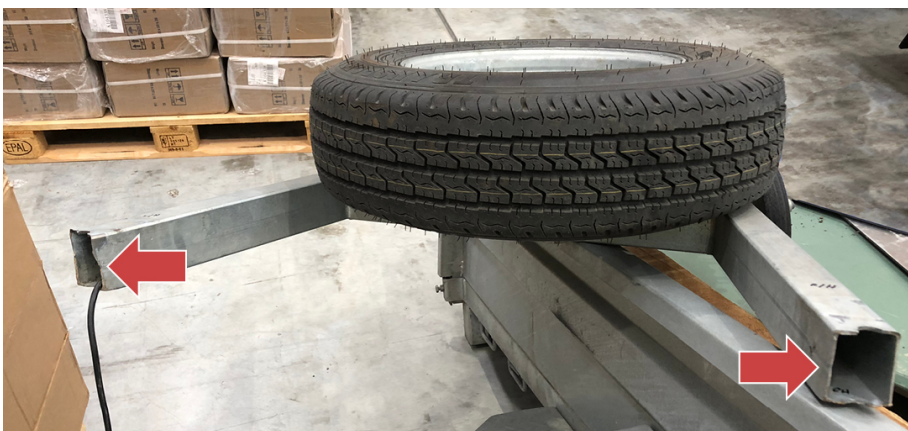
Broken drawbar (sitting on trailer)

There is a safety risk with the Trailpro brand of light trailers which were sold through Bunnings NZ between 1 January 2006 and 12 October 2018. **Bunnings is now recalling all Trailpro trailers, other than Trailpro 8x4 Tradesman (TP5) or 8x5 Tandem (TP8) models that have undergone Bunnings-approved repairs as part of an earlier recall. These can be identified by the serial number on the identification plate ending with an "R" (see Figure 3-1-6). A TP5 or TP8 trailer with a serial number ending with an "R" may be issued a WoF if it passes all other checks.** More information can be found in the [safety recall notice](#) on the Transport Agency website.

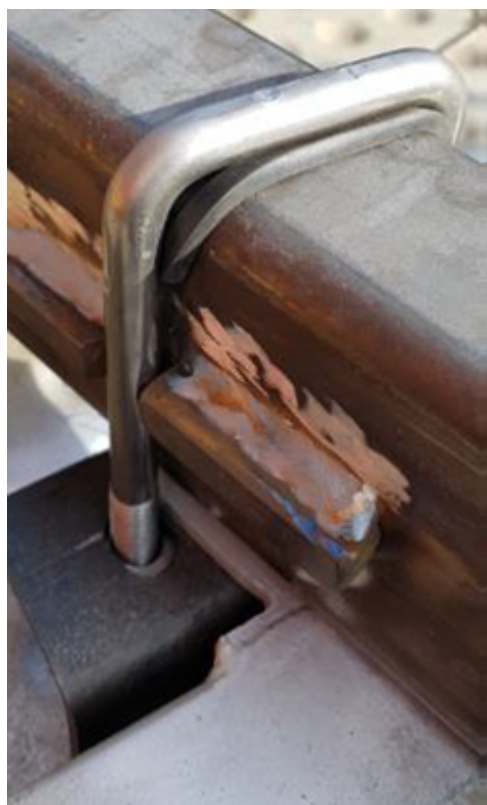
Figure 8-1-4. New front mount of the repaired Trailpro 8x4 and 8x5 trailers

6. The trailer is an unrepaired Trailpro 8x4 Tradesman (model number TP5) or a Trailpro 8x5 Tandem (model number TP8), with a bolt-through drawbar attachment (these trailers are subject to safety recall) (Note 4). See Figure 8-1-2 for advice on identifying these trailers. See Figure 8-1-3 and Figure 8-1-4 for advice on identifying repaired Trailpro trailers.
