Extract taken from: In-service certification (WoF and CoF) > General trailers > Towing connections

8 Towing connections

8-1 Light trailer drawbar and kingpin

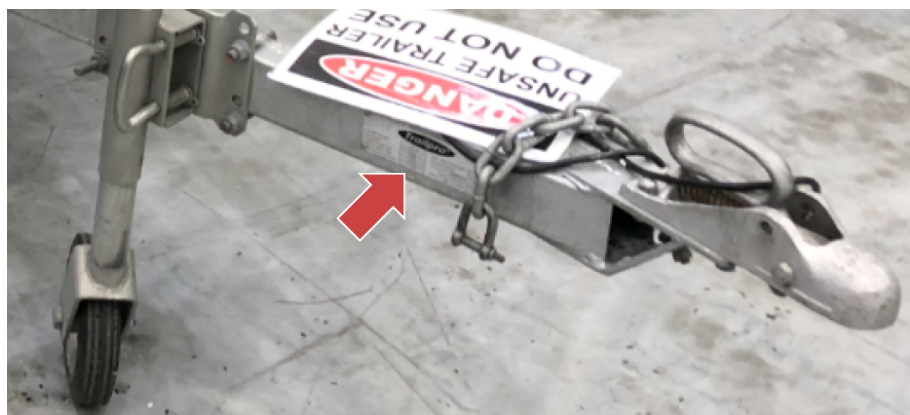
Figure 8-1-2. Identifying a Trailpro TP5 and TP8

Affected trailers are fitted with an identification plate which is located on the outside of the trailer drawbar near the tow coupling.

Location of the trailer identification plate

6. The trailer is an unrepaired Trailpro 8x4 Tradesman (model number TP5) or a Trailpro 8x5 Tandem (model number TP8), with a bolt-through drawbar attachment (these trailers are subject to safety recall) (Note 4). See Figure 8-1-2 for advice on identifying these trailers. See Figure 8-1-3 and Figure 8-1-4 for advice on identifying repaired Trailpro trailers.
