Extract taken from: Alternative fuel system certification > CNG inspection > Fuel service line

2-8 Fuel service line

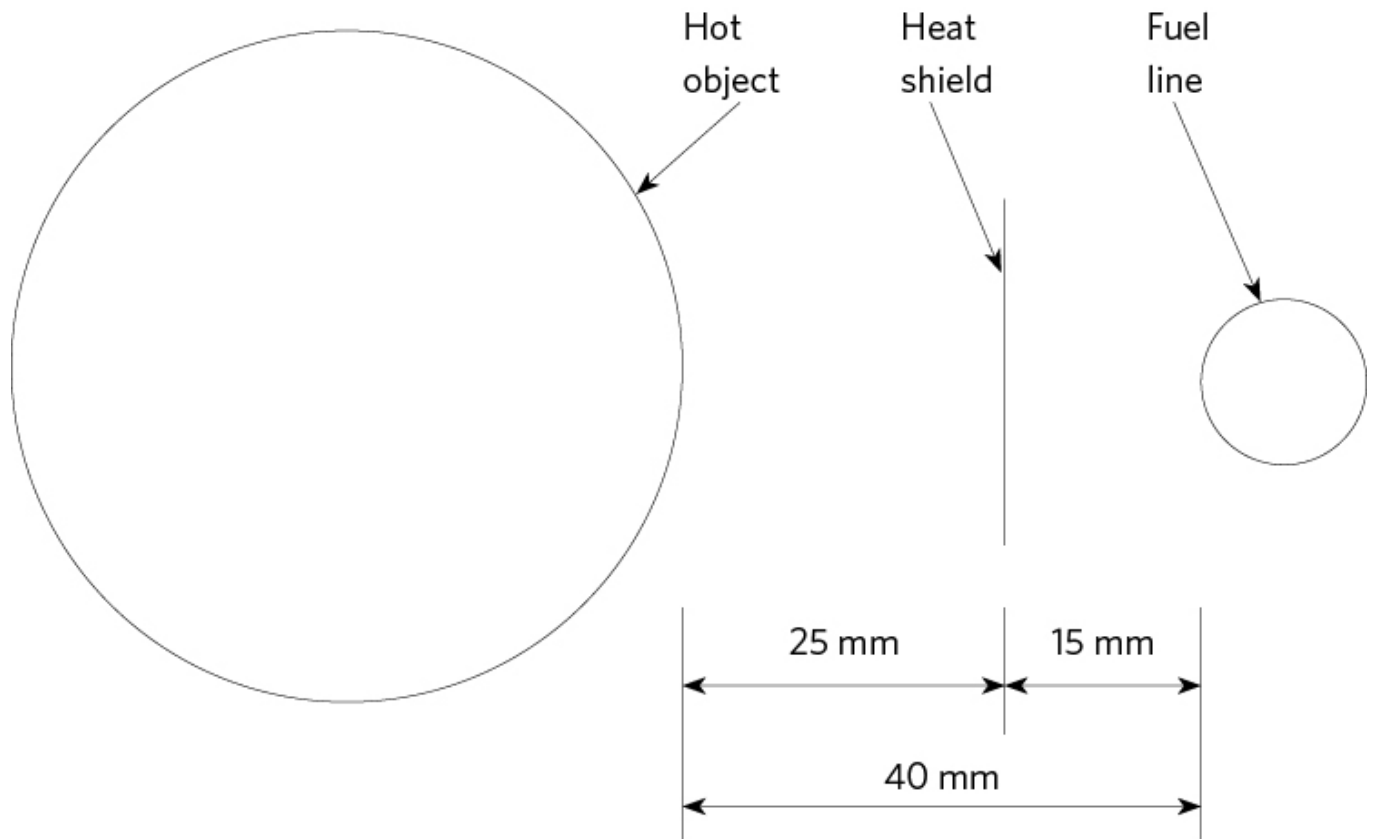
Figure 2-8-1. Minimum fuel line distance to hot object with heat shield

1. A fuel service line enters an enclosed driver, passenger or luggage compartment (Note 1).
2. A fuel service line in a drive shaft tunnel is within 40mm of the drive shaft under some operating conditions.
3. The underside of a fuel service line in a drive shaft tunnel is more than 15mm of the intersection of the drive shaft tunnel and the floor pan.
4. Required fuel line protection is missing.
5. A required clip or grommet is missing.
6. A pipe, component or fitting that is not fully protected by a radiation shield at least 15mm away is within 150mm of a hot object at a temperature above the normal water jacket temperature.
7. A pipe, component or fitting that is fully protected by a radiation shield at least 15mm away is within 40mm of a hot object at a temperature above the normal water jacket temperature (Figure 2-8-1).

9. A pipe, component or fitting that is fully protected by a radiation shield at least 15mm away, must not be within 40mm of a hot object at a temperature above the normal water jacket temperature (Figure 2-8-1).
