Extract taken from: In-service certification (WoF and CoF) > Technical bulletins (general) > Shock absorbers – misting vs excessive leakage

9 Shock absorbers – misting vs excessive leakage

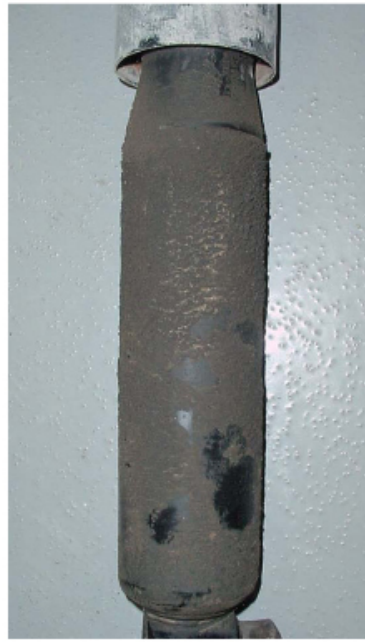
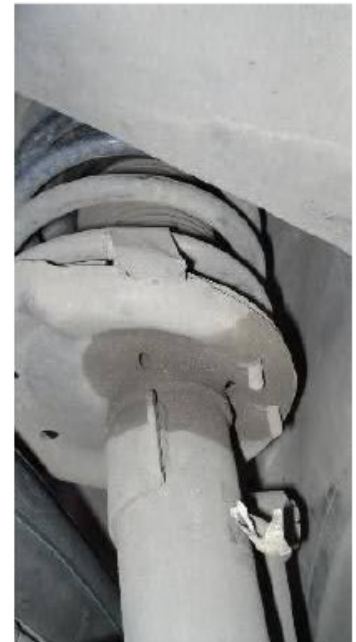
Examples of misting shock absorbers (PASS):

Misting is normal on shock absorbers and must pass for WoF/CoF.

By design, the piston rod carries a film of oil through the rod seal to lubricate the seal lips, thereby reducing friction/wear at the seal contact area, and prolonging seal life. Misting occurs when the hot piston rod is drawn out of the shock body and the microscopic film of hot oil on the rod turns to vapour. This vapour, or mist, condenses when it reaches the cooler outside air, and forms a film on the outside of the shock body. The film will attract road dust and debris, and will often coat the entire body of the shock.

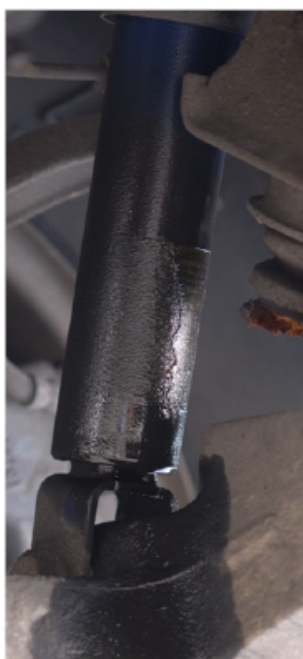
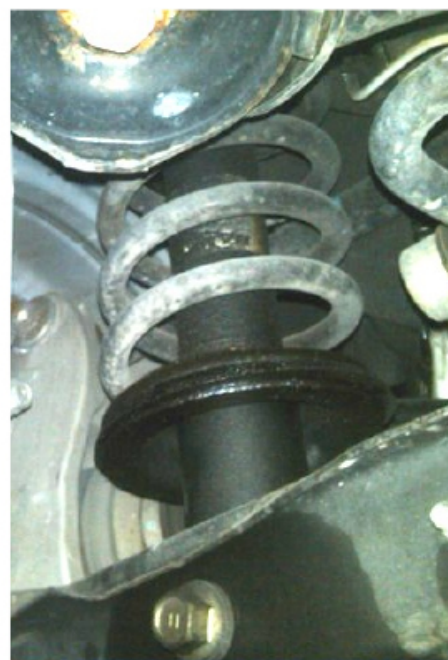
Examples of excessively leaking shock absorbers (FAIL):

Rod seals may leak as a result of extreme wear, contamination, or defect. A leaking shock will show clear signs of oil leaking in streams from the upper seal down the shock body and may drip from the shock.

Such leakage is considered to be excessive and must be failed for WoF/CoF.
