Extract taken from: In-service certification (WoF and CoF) > Technical bulletins (general) > Shock absorbers – misting vs excessive leakage

9 Shock absorbers – misting vs excessive leakage

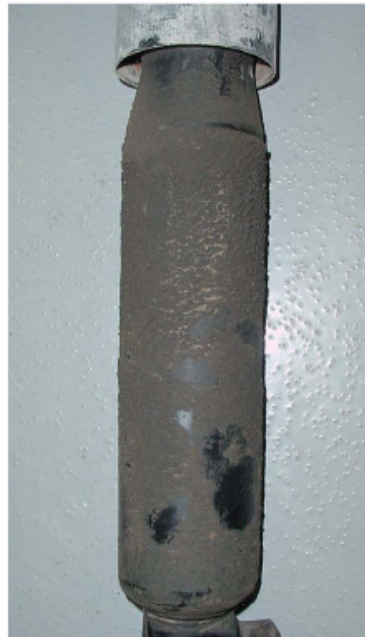
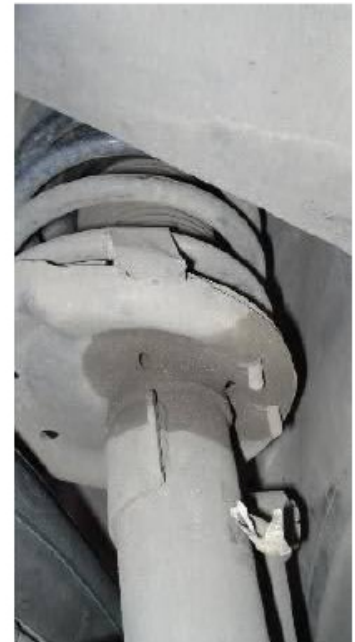
Examples of misting shock absorbers (PASS):

Misting is normal on shock absorbers and must pass for WoF/CoF.

By design, the piston rod carries a film of oil through the rod seal to lubricate the seal lips, thereby reducing friction/wear at the seal contact area, and prolonging seal life. Misting occurs when the hot piston rod is drawn out of the shock body and the microscopic film of hot oil on the rod turns to vapour. This vapour, or mist, condenses when it reaches the cooler outside air, and forms a film on the outside of the shock body. The film will attract road dust and debris, and will often coat the entire body of the shock.

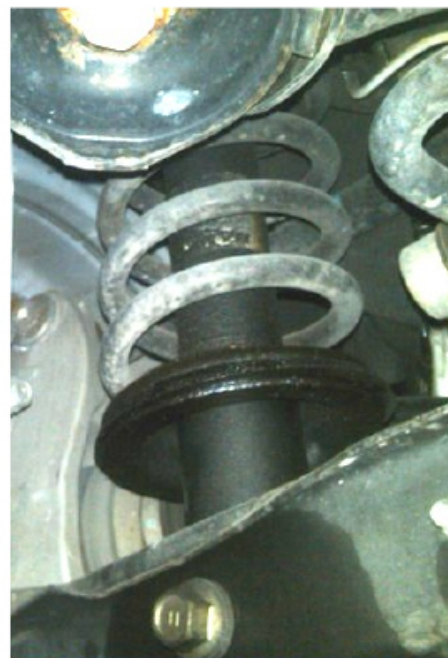
Examples of excessively leaking shock absorbers (FAIL):

Rod seals may leak as a result of extreme wear, contamination, or defect. A leaking shock will show clear signs of oil leaking in streams from the upper seal down the shock body and may drip from the shock.

Such leakage is considered to be excessive and must be failed for WoF/CoF.

Note: Some minor streaking of oil may appear on a new shock body during initial stroking. This is the result of the seal “setting” and purging any oil (from assembly) from the seal. This is not to be mistaken as a failure, as it is temporary and totals only a few millilitres of oil.
