**Extract taken from:** In-service certification (WoF and CoF) > Technical bulletins (general) > Shock absorbers – misting vs excessive leakage

## 9 Shock absorbers – misting vs excessive leakage

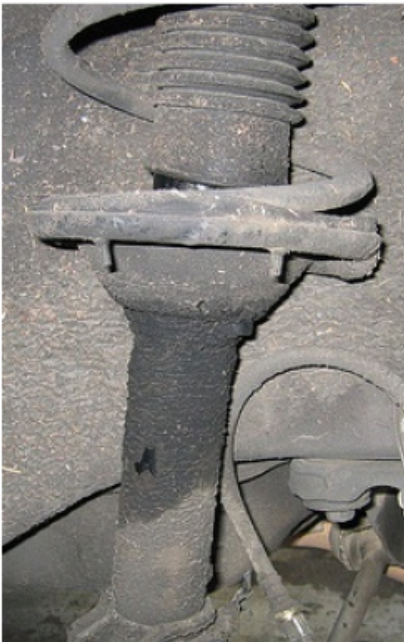
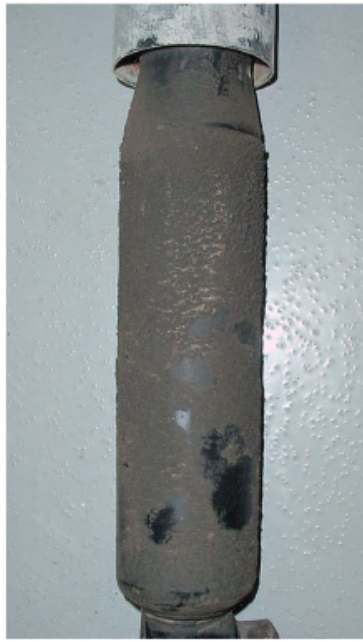
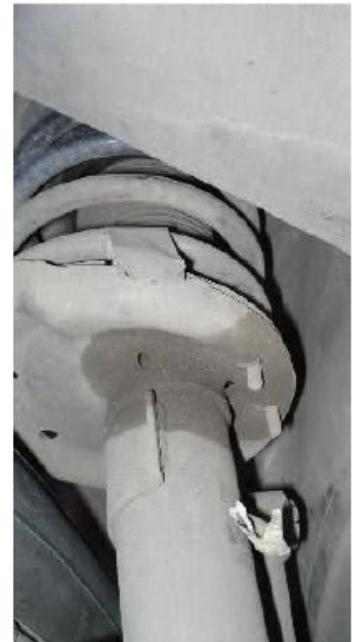
**Examples of misting shock absorbers (PASS):**

**Misting is normal on shock absorbers and must pass for WoF/CoF.**

By design, the piston rod carries a film of oil through the rod seal to lubricate the seal lips, thereby reducing friction/wear at the seal contact area, and prolonging seal life. Misting occurs when the hot piston rod is drawn out of the shock body and the microscopic film of hot oil on the rod turns to vapour. This vapour, or mist, condenses when it reaches the cooler outside air, and forms a film on the outside of the shock body. The film will attract road dust and debris, and will often coat the entire body of the shock.

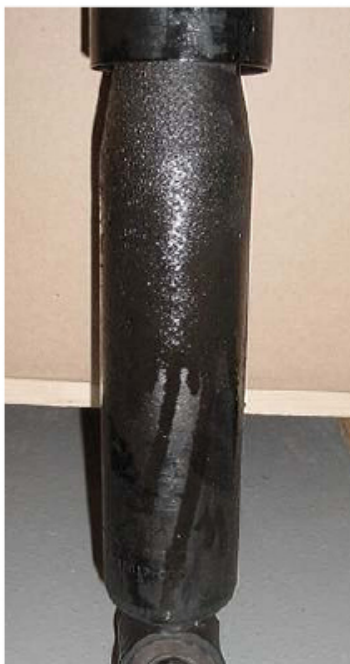
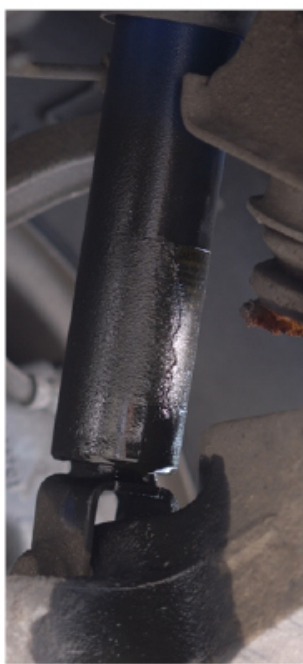
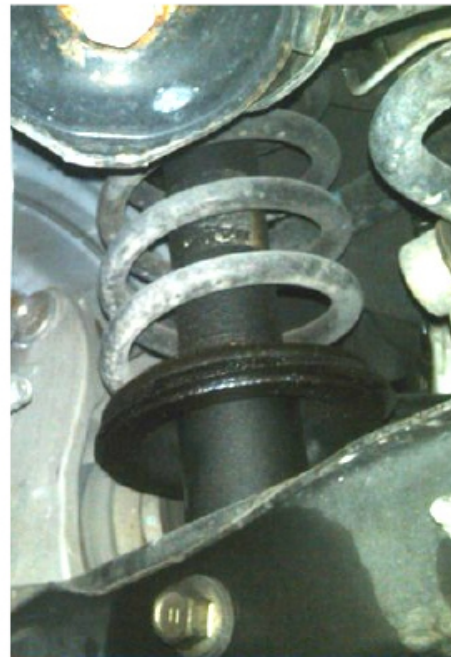
**Examples of excessively leaking shock absorbers (FAIL):**

Rod seals may leak as a result of extreme wear, contamination, or defect. A leaking shock will show clear signs of oil leaking in streams from the upper seal down the shock body and may drip from the shock.

Such leakage is considered to be excessive and must be failed for WoF/CoF.
