Extract taken from: In-service certification (WoF and CoF) > General trailers > Towing connections > Light trailer drawbar and kingpin

8-1 Light trailer drawbar and kingpin

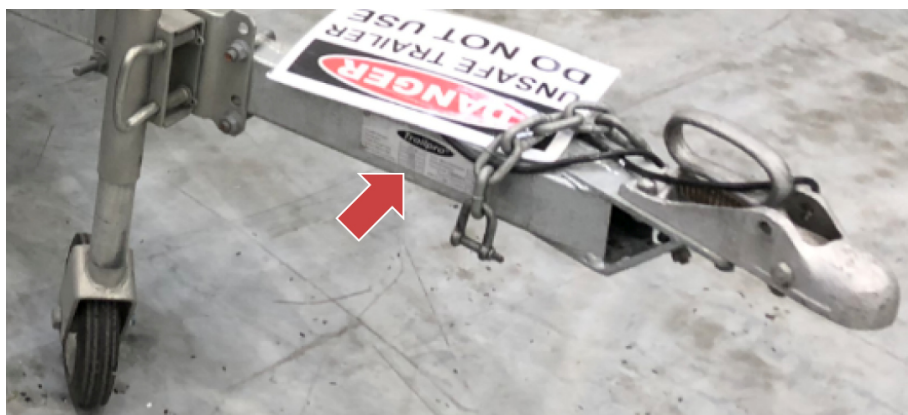
Affected trailers are fitted with an identification plate which is located on the outside of the trailer drawbar near the tow coupling.

Location of the trailer identification plate

Figure 8-1-2. Identifying a Trailpro TP5 and TP8

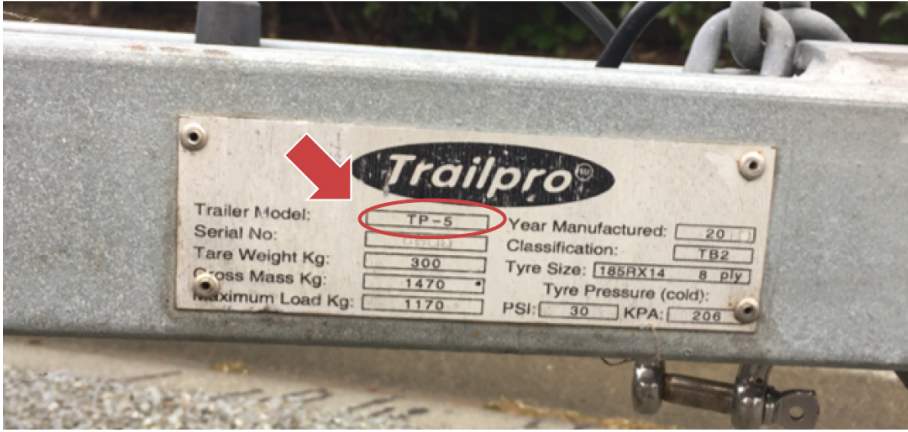
Identification plate similar showing model number

The identification tag may be missing, faded, damaged or obscured. All Trailpro models have drawbars that are **bolted rather than welded** to the trailer. The TP5 has a single axle and a tray size of 8'x4' (2.4m x 1.2m). The TP8 is a tandem axle model with a tray size of 8'x5' (2.4m x 1.5m).

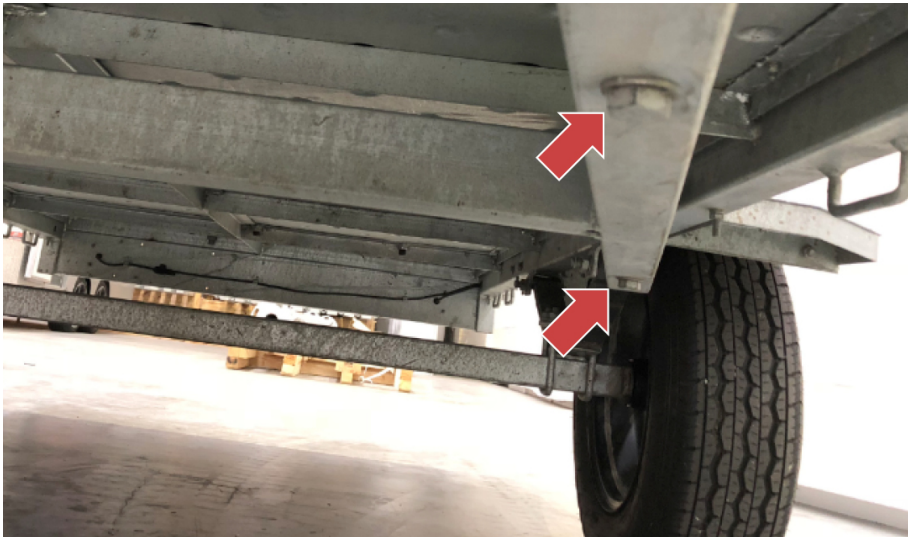
Bolted through drawbar attachment to trailer

6. The trailer is an unrepaired Trailpro 8x4 Tradesman (model number TP5) or a Trailpro 8x5 Tandem (model number TP8), with a bolt-through drawbar attachment (these trailers are subject to safety recall) (Note 4). See Figure 8-1-2 for advice on identifying these trailers. See Figure 8-1-3 and Figure 8-1-4 for advice on identifying repaired Trailpro trailers.

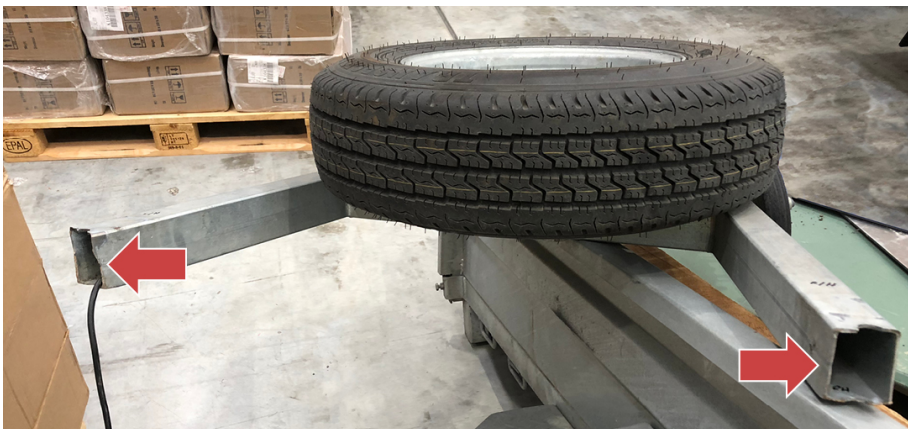
Broken drawbar (sitting on trailer)

There is a safety risk with the Trailpro brand of light trailers which were sold through Bunnings NZ between 1 January 2006 and 12 October 2018. Bunnings is now recalling all Trailpro trailers, other than Trailpro 8x4 Tradesman (TP5) or 8x5 Tandem (TP8) models that have undergone Bunnings-approved repairs as part of an earlier recall. These can be identified by the serial number on the identification plate ending with an "R" (see Figure 3-1-6). A TP5 or TP8 trailer with a serial number ending with an "R" may be issued a WoF if it passes all other checks. More information can be found in the [safety recall notice](#) on the Transport Agency website.

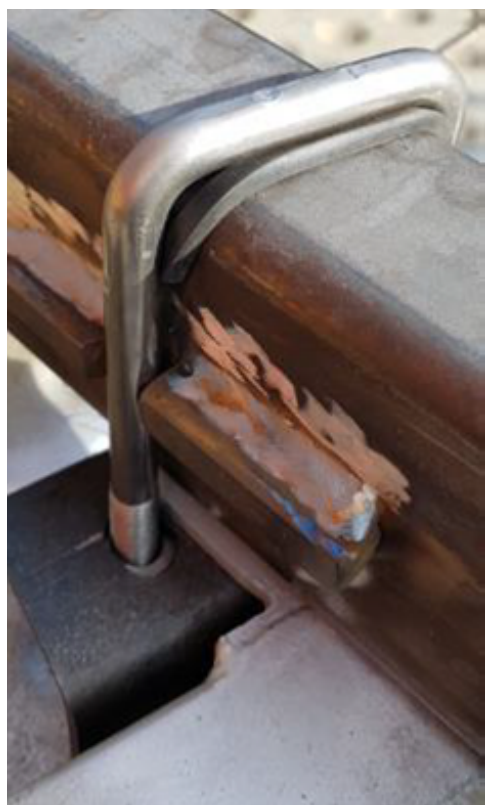
Figure 8-1-4. New front mount of the repaired Trailpro 8x4 and 8x5 trailers
