Extract taken from: In-service certification (WoF and CoF) > General trailers > Towing connections > Light trailer drawbar and kingpin

8-1 Light trailer drawbar and kingpin

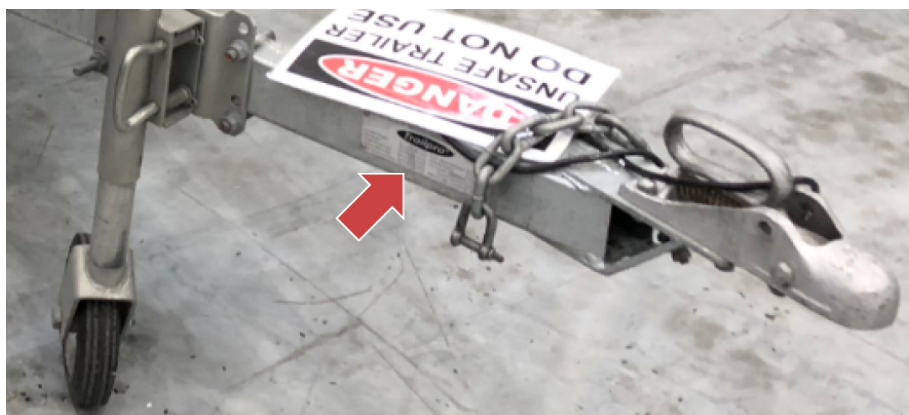
Affected trailers are fitted with an identification plate which is located on the outside of the trailer drawbar near the tow coupling.

Location of the trailer identification plate

6. The trailer is an unrepaired Trailpro 8x4 Tradesman (model number TP5) or a Trailpro 8x5 Tandem (model number TP8), with a bolt-through drawbar attachment (these trailers are subject to safety recall) (Note 4). See Figure 8-1-2 for advice on identifying these trailers. See Figure 8-1-3 and Figure 8-1-4 for advice on identifying repaired Trailpro trailers.

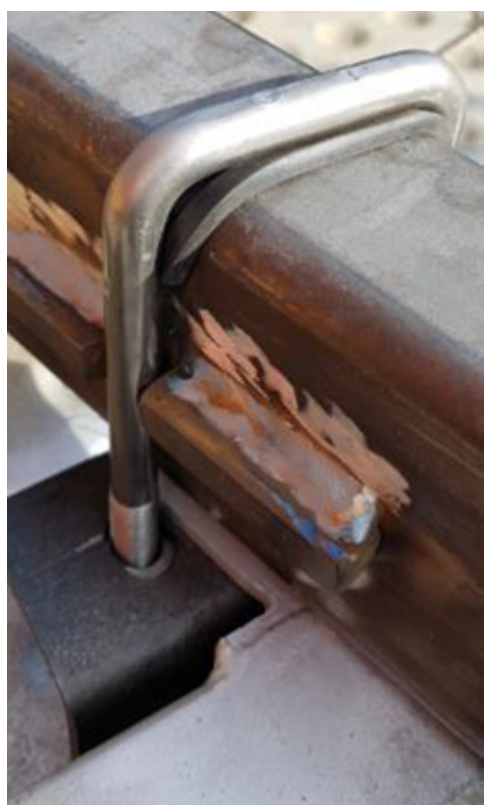
Figure 8-1-4. New front mount of the repaired Trailpro 8x4 and 8x5 trailers
