Extract taken from: In-service certification (WoF and CoF) > General trailers > Towing connections > Light trailer drawbar and kingpin

8-1 Light trailer drawbar and kingpin

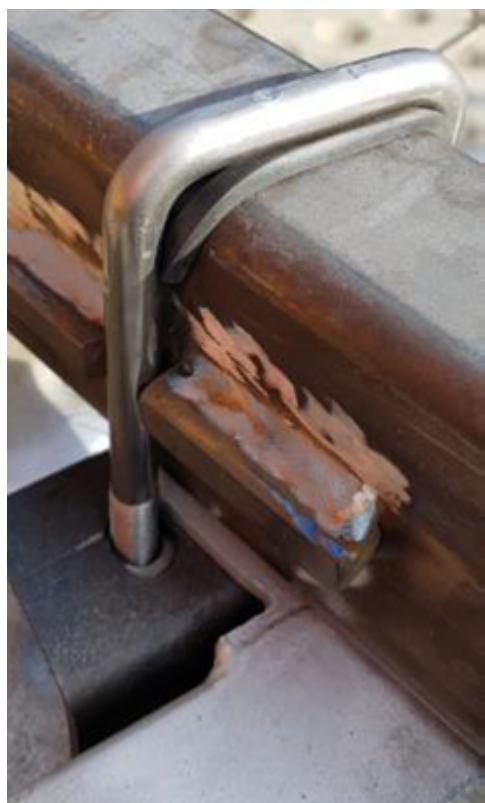
Figure 8-1-4. New front mount of the repaired Trailpro 8x4 and 8x5 trailers

6. The trailer is an unrepaired Trailpro 8x4 Tradesman (model number TP5) or a Trailpro 8x5 Tandem (model number TP8), with a bolt-through drawbar attachment (these trailers are subject to safety recall) (Note 4). See Figure 8-1-2 for advice on identifying these trailers. See Figure 8-1-3 and Figure 8-1-4 for advice on identifying repaired Trailpro trailers.
