Extract taken from: Entry certification > Reference materials > Examples of major structural damage and corrosion

71 Examples of major structural damage and corrosion

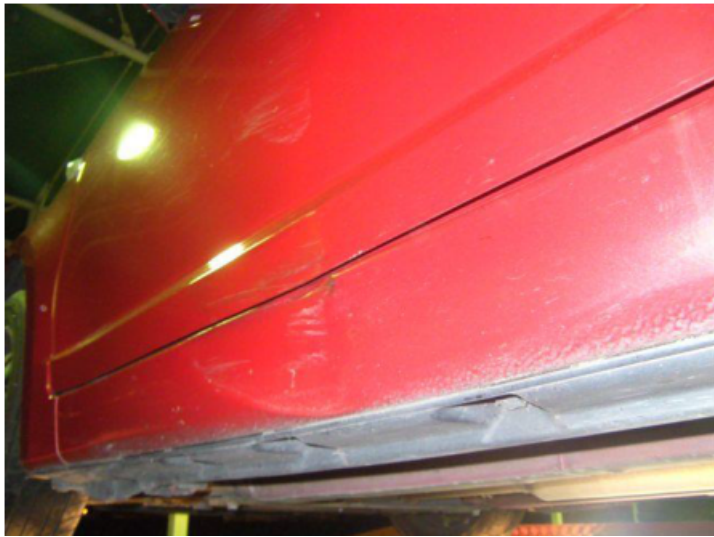
71-4 Damage to rocker panels and cant rails

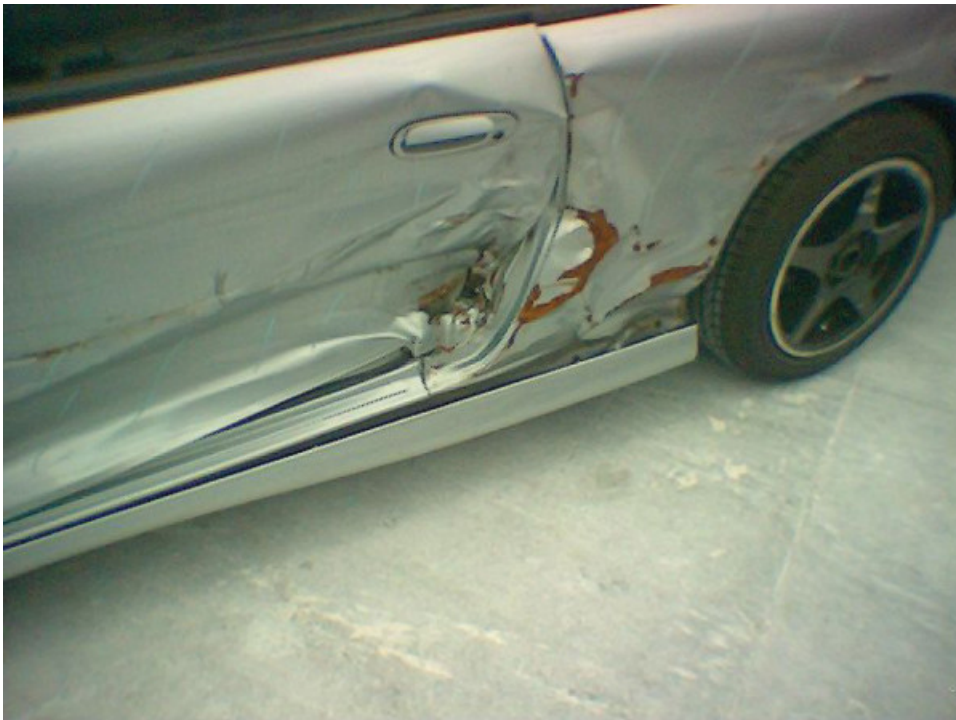
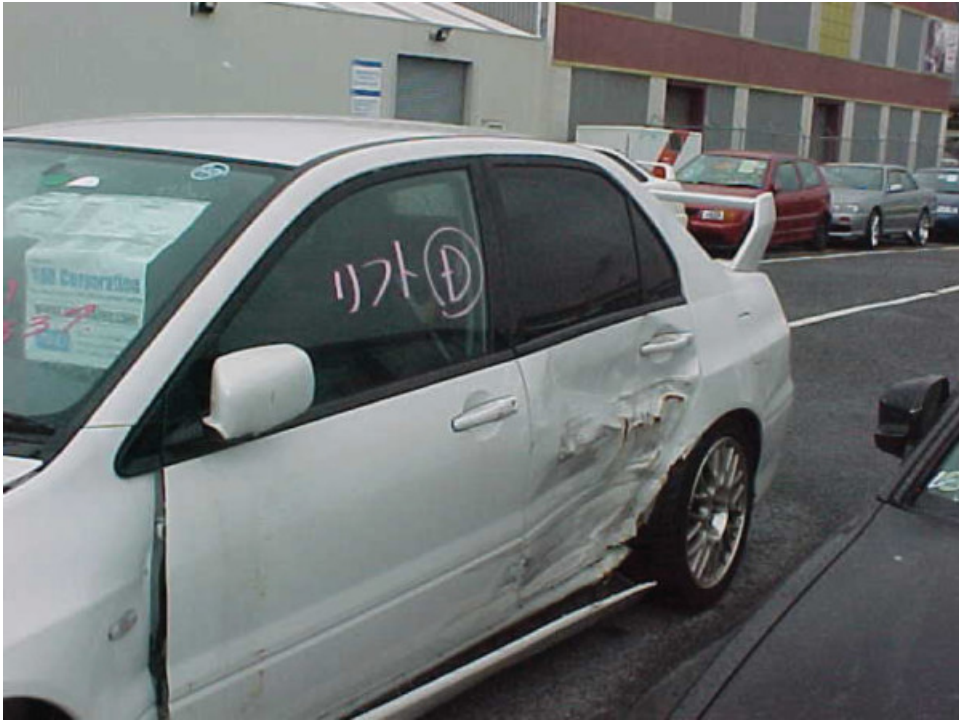
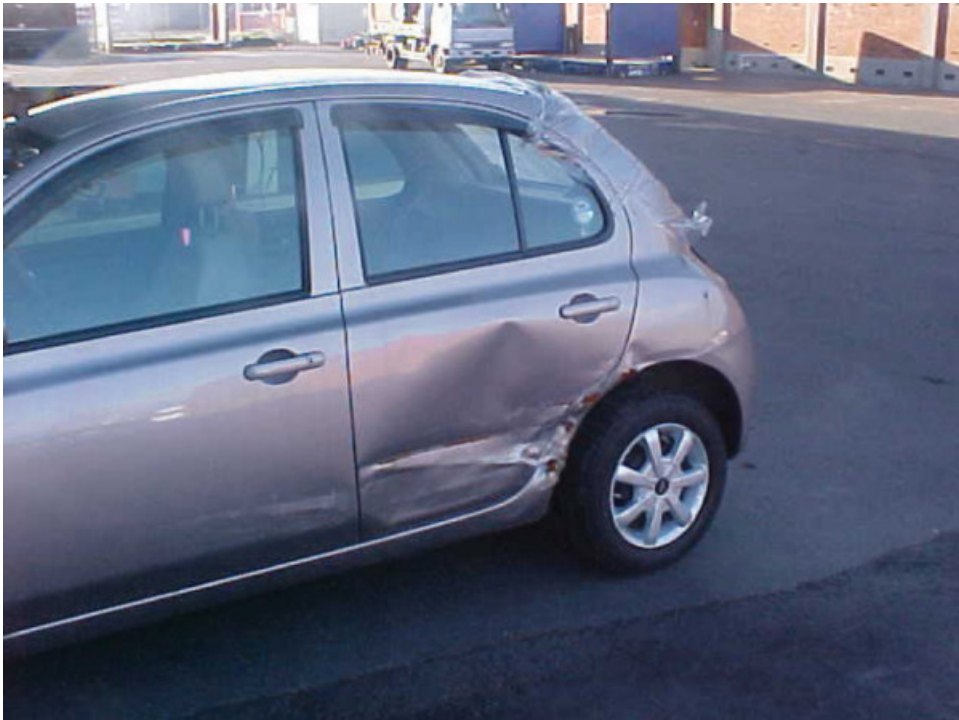
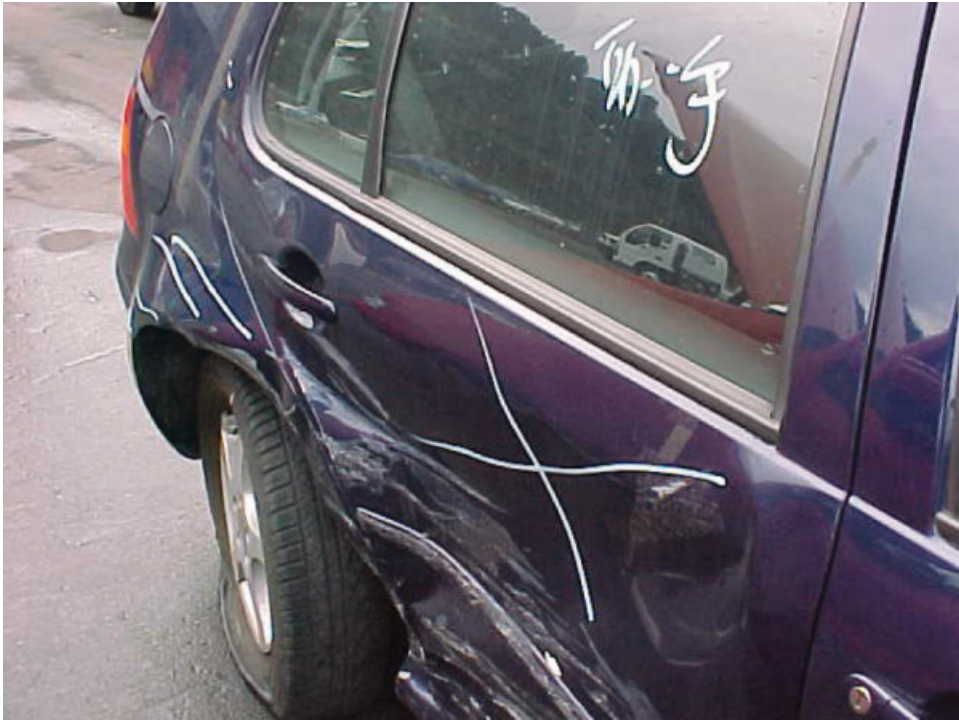
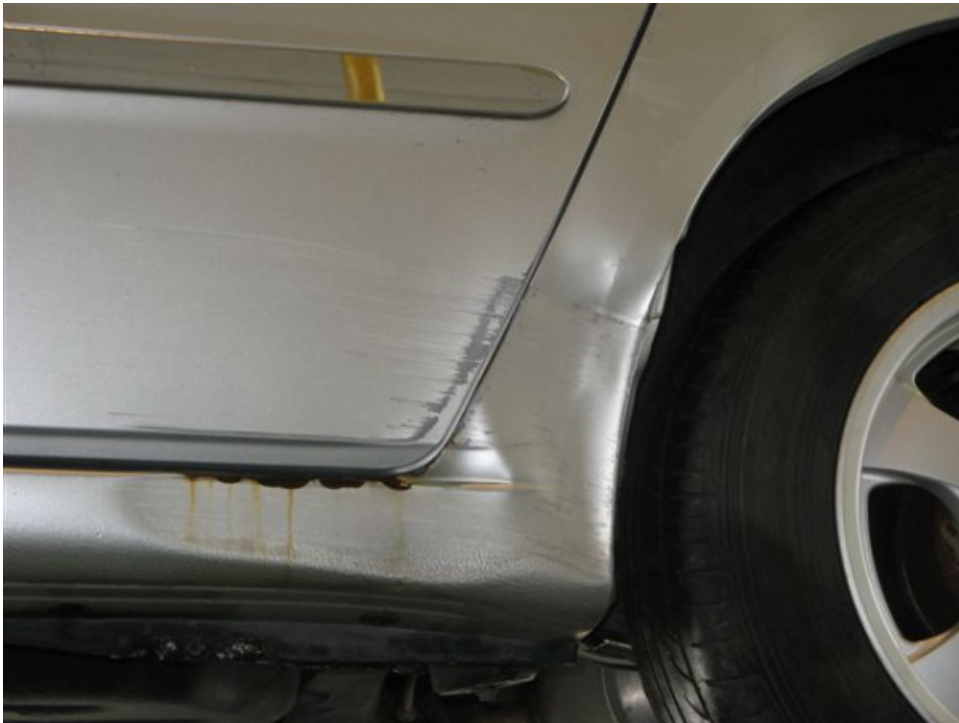
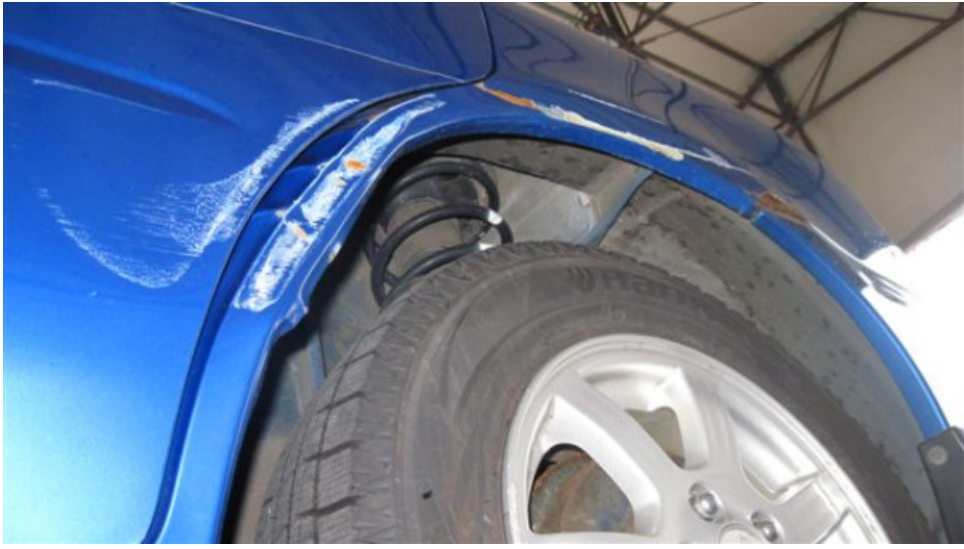
71-5 Rear quarter/dogleg

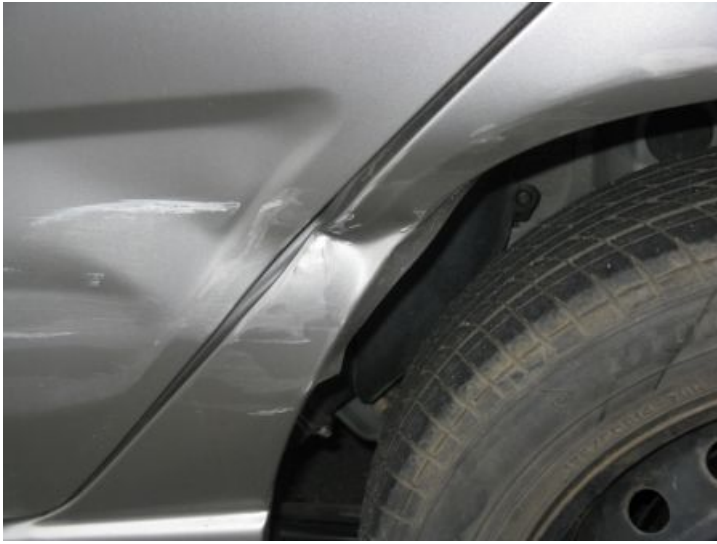
71-6 Dogleg flag

Look for discrepancies in the door gap.

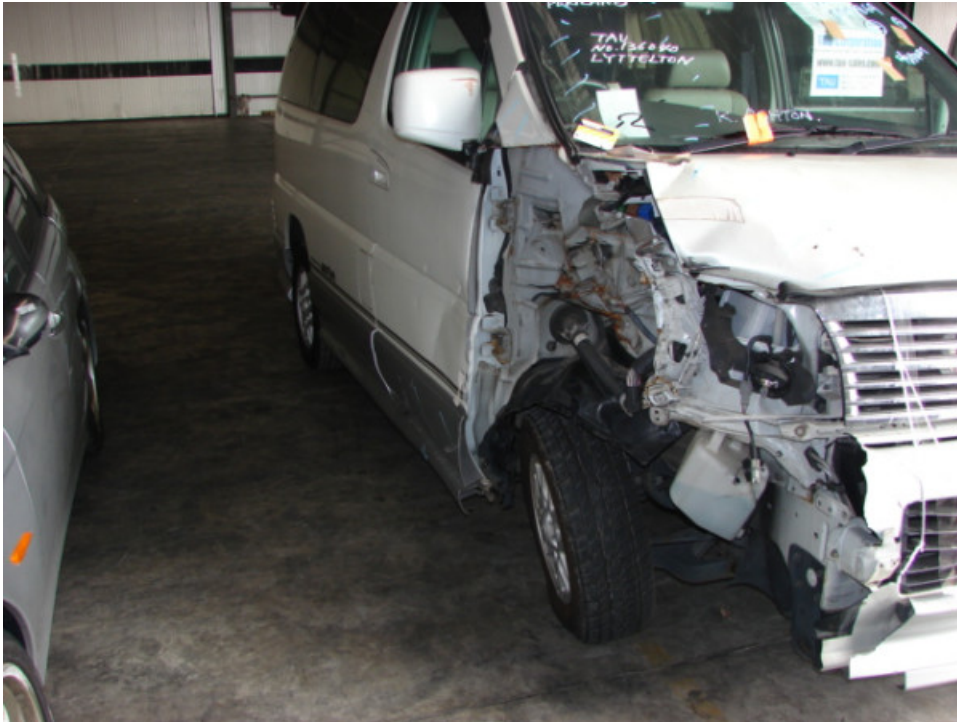
71-7 Distortion to longitudinal rails: front and rear crush zones

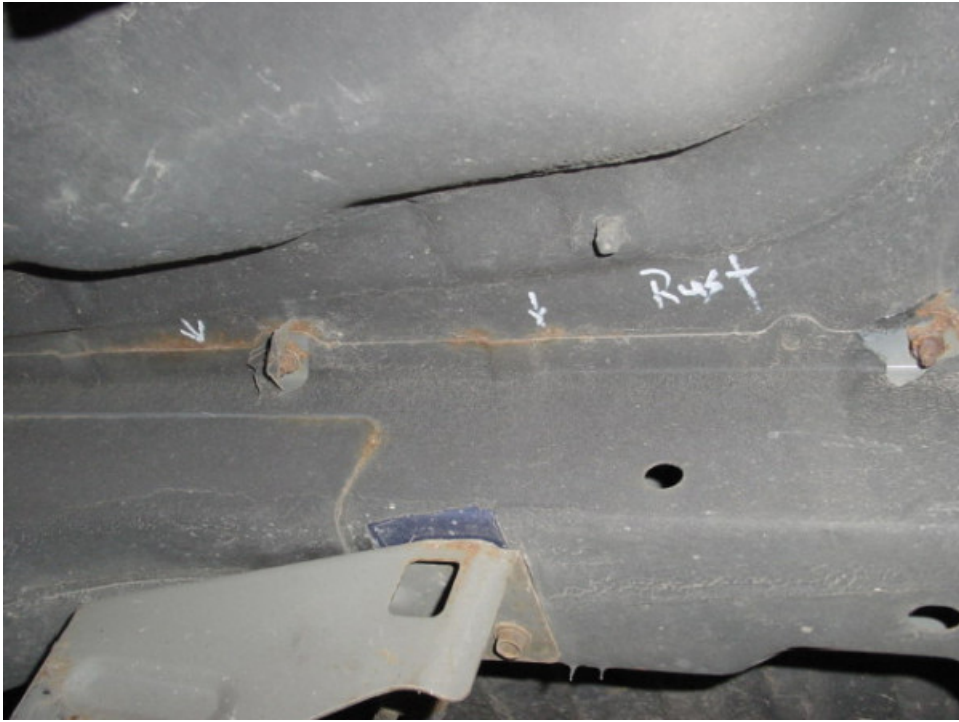
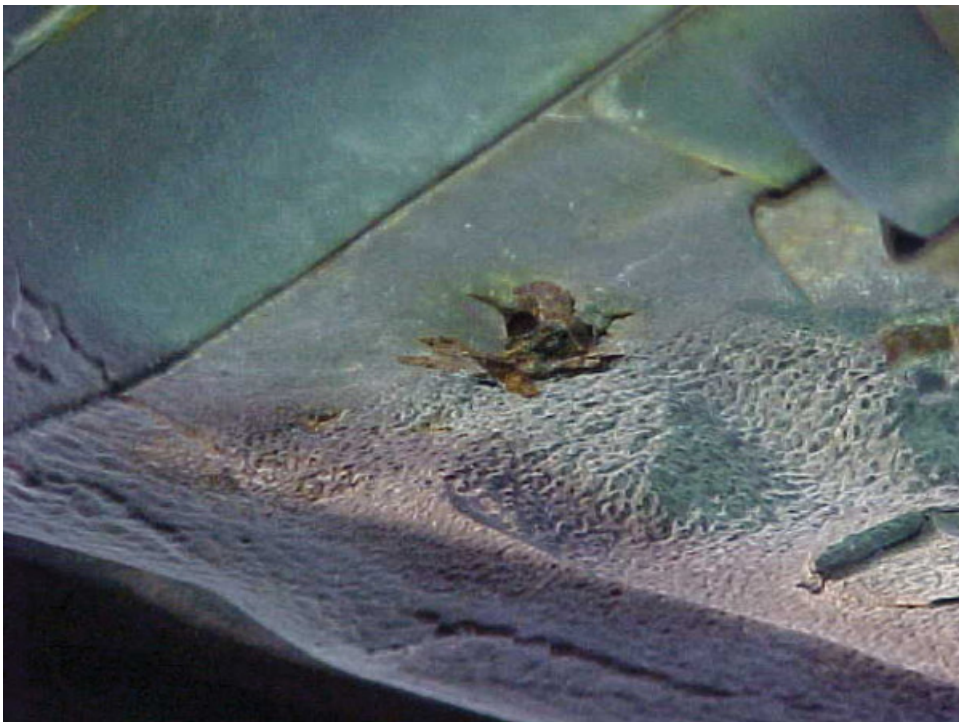
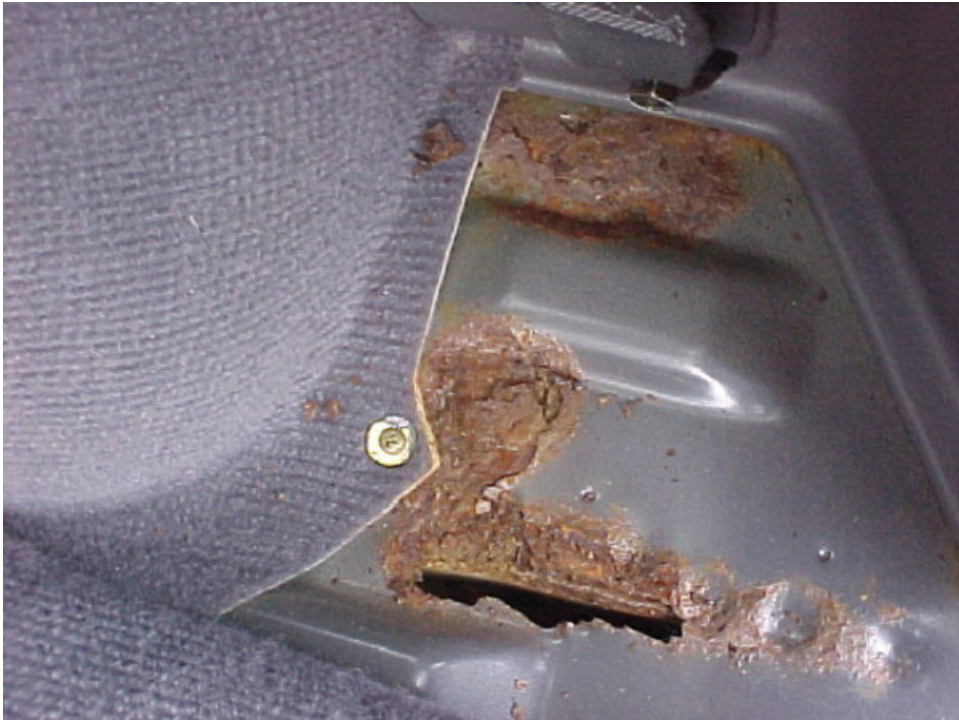
71-10 Corrosion which has resulted in perforation or flaking of the metal: Nissan Terrano and Mistral

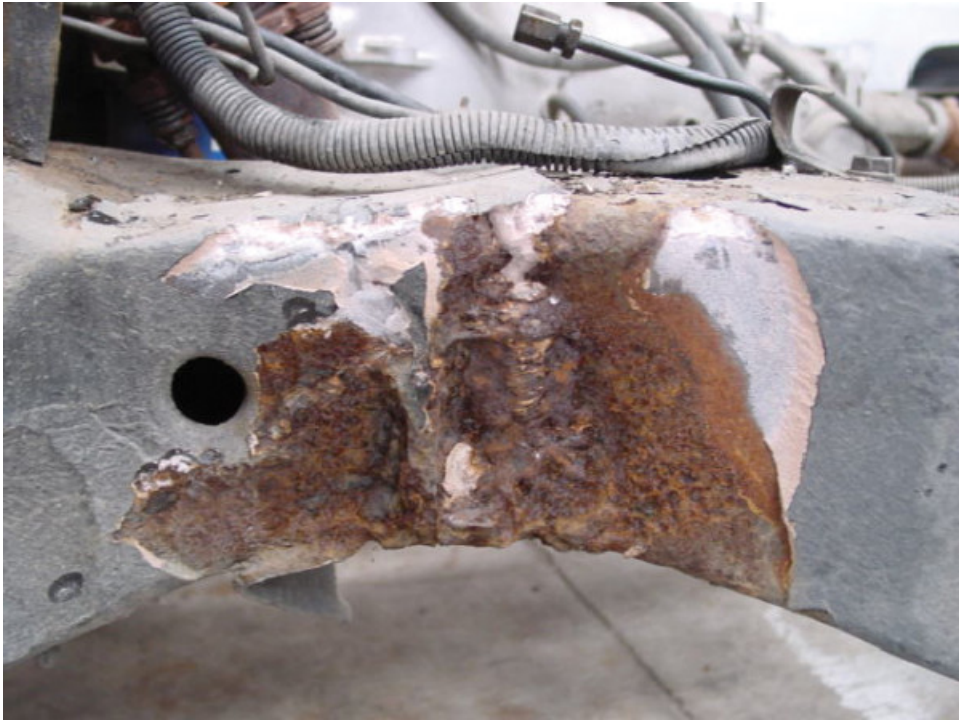
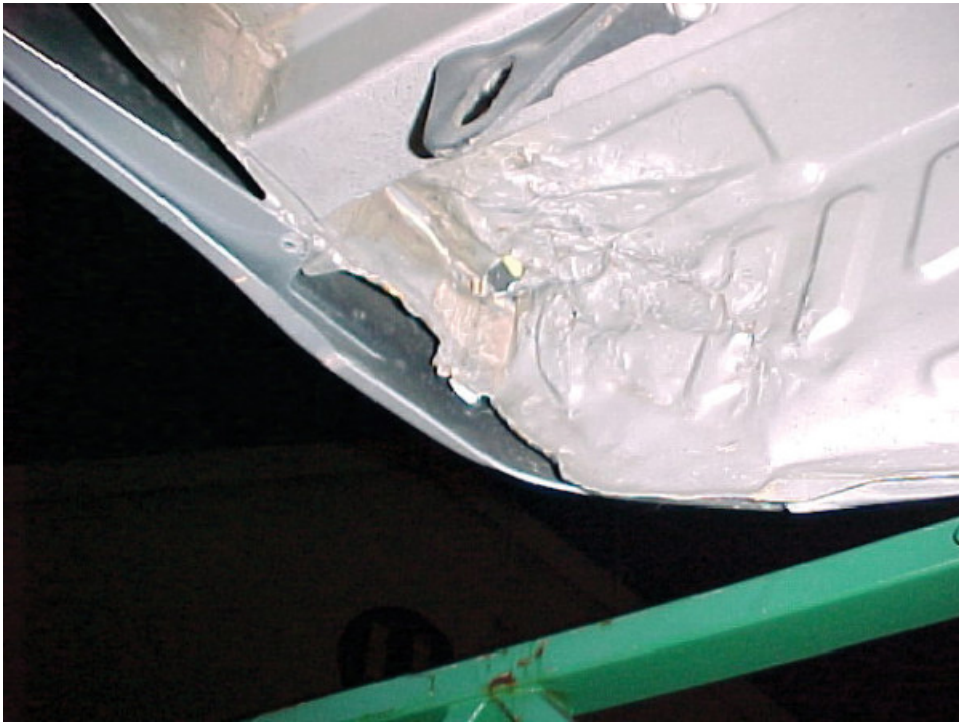
71-13 Examples of repairs
